Architectural  
Services  
Department

## **CLONDALKIN ROUND TOWER VISITORS' CENTRE**

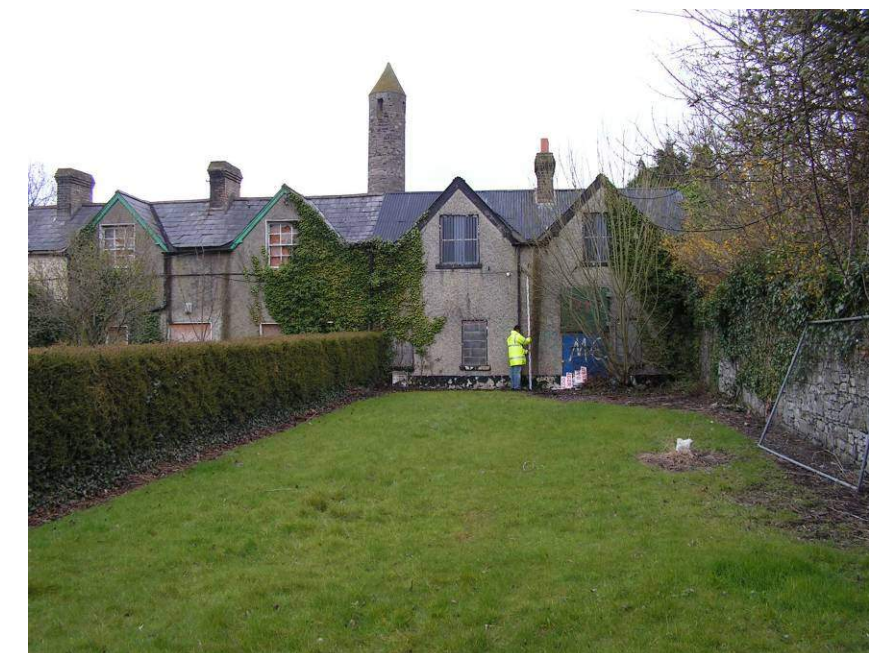
Fig. 1.6. Number 1 Millview Terrace (right side) and number 2 (left side) viewed from the north with the round tower in the background.

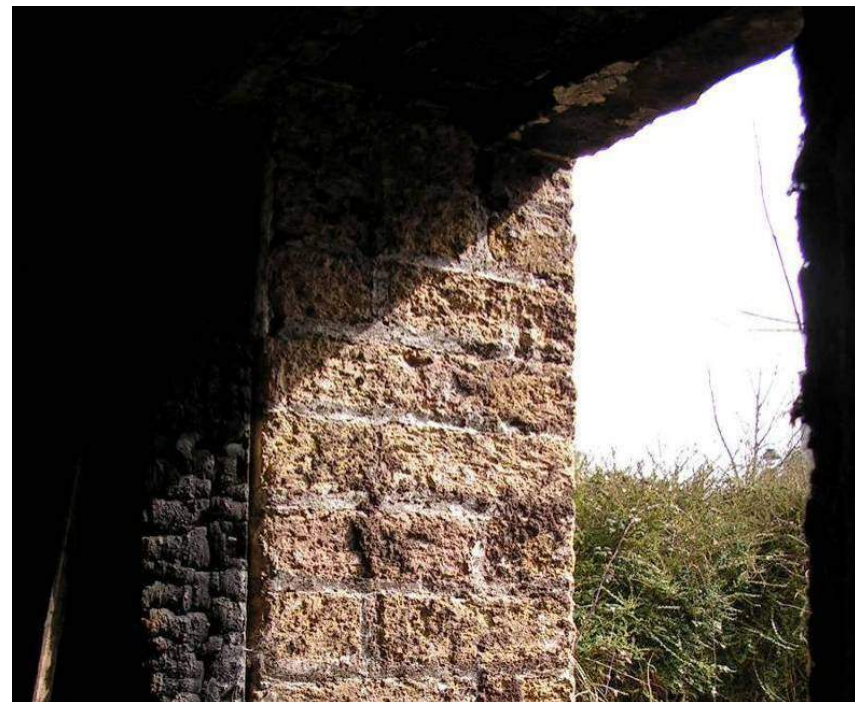
Fig. 3.1. The brick reveals at the back door of the house of 1 Millview Terrace. These were exposed after the building was damaged by fire; a charred door frame is visible on the left side of the photograph

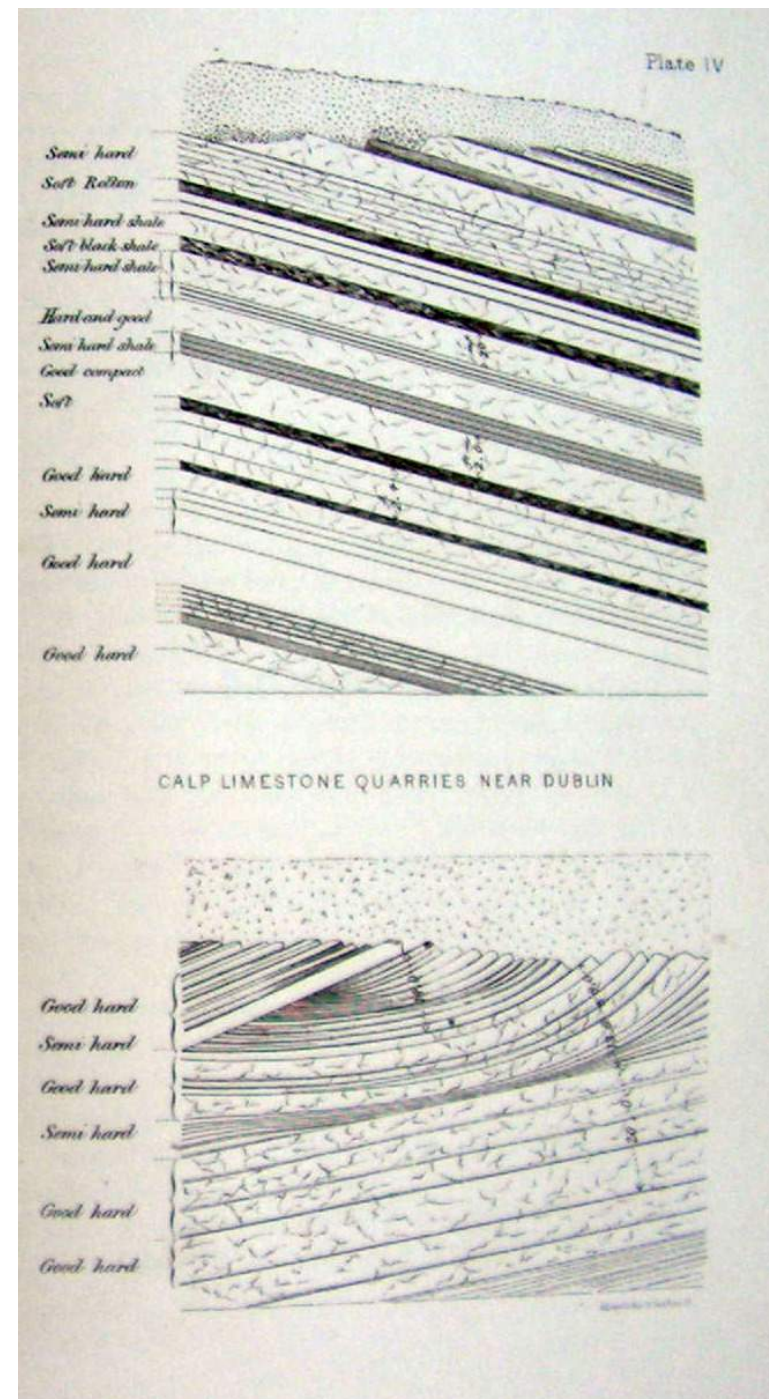
Fig. 3.2. A diagram of calp limestone quarries, copied from Wilkinson G. “Practical Geology and ancient architecture of Ireland” (1845, William Corey Jr. & Co., Dublin) (Plate IV, between pages 38 and 39)

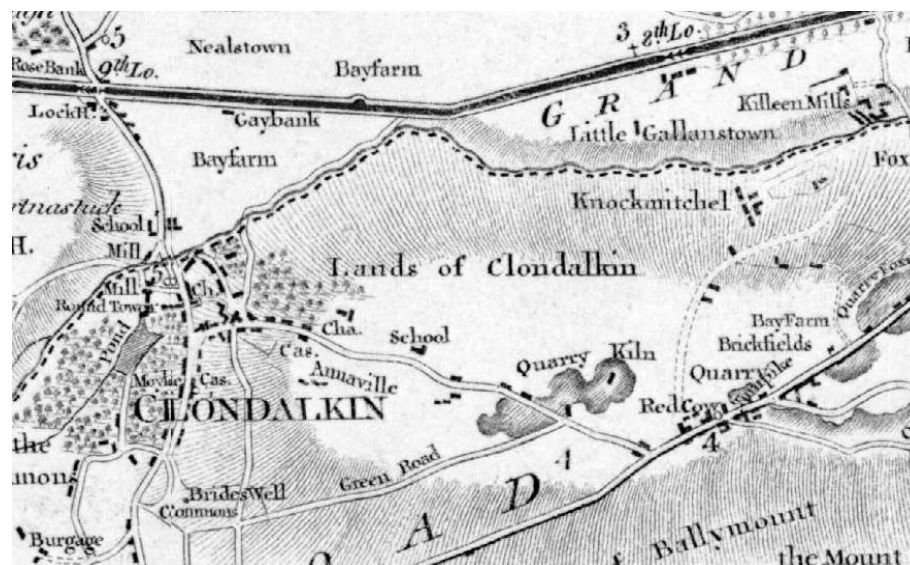
Fig. 3.4. An extract from Taylor’s map of south county Dublin, published 1816. Note the references to “Quarry” “Kiln” and “Brickfields” at the east end of Knockmeenagh Lane, recorded as “Green Road”.

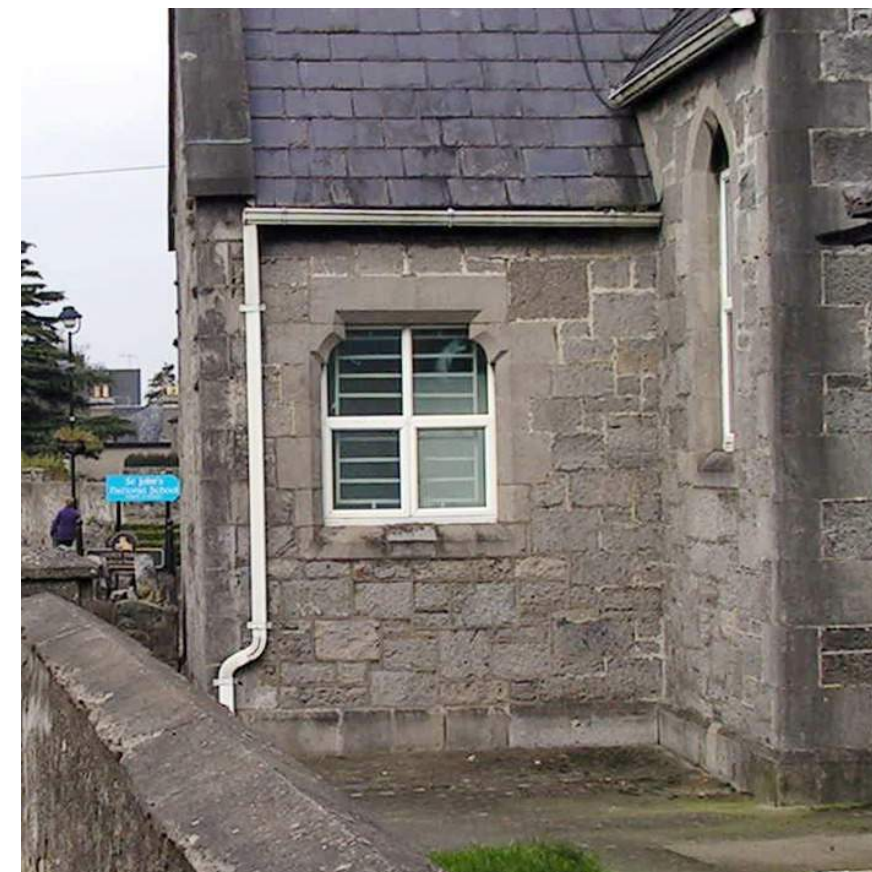
Fig. 3.5. The school building, Church Terrace, viewed from the south (built circa 1880), photographed April 2013. The window opening was formerly a door. All the timber windows have been replaced with uPVC. The wall in the left foreground has been reduced and was once rendered. Part of the wall is shown on Fig. 3.12 A on the following pages.

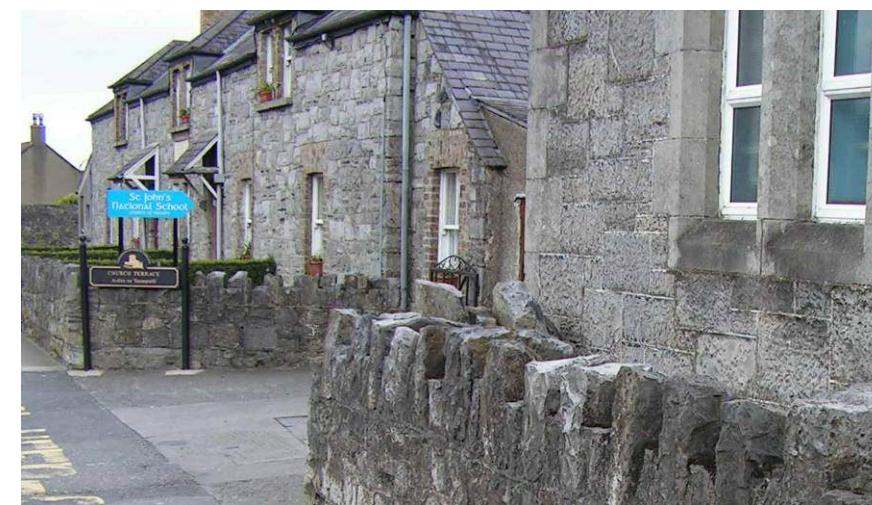
Fig. 3.6. A photograph of the almshouses with their brick lined openings on the left. A corner of the school building is shown on the right.

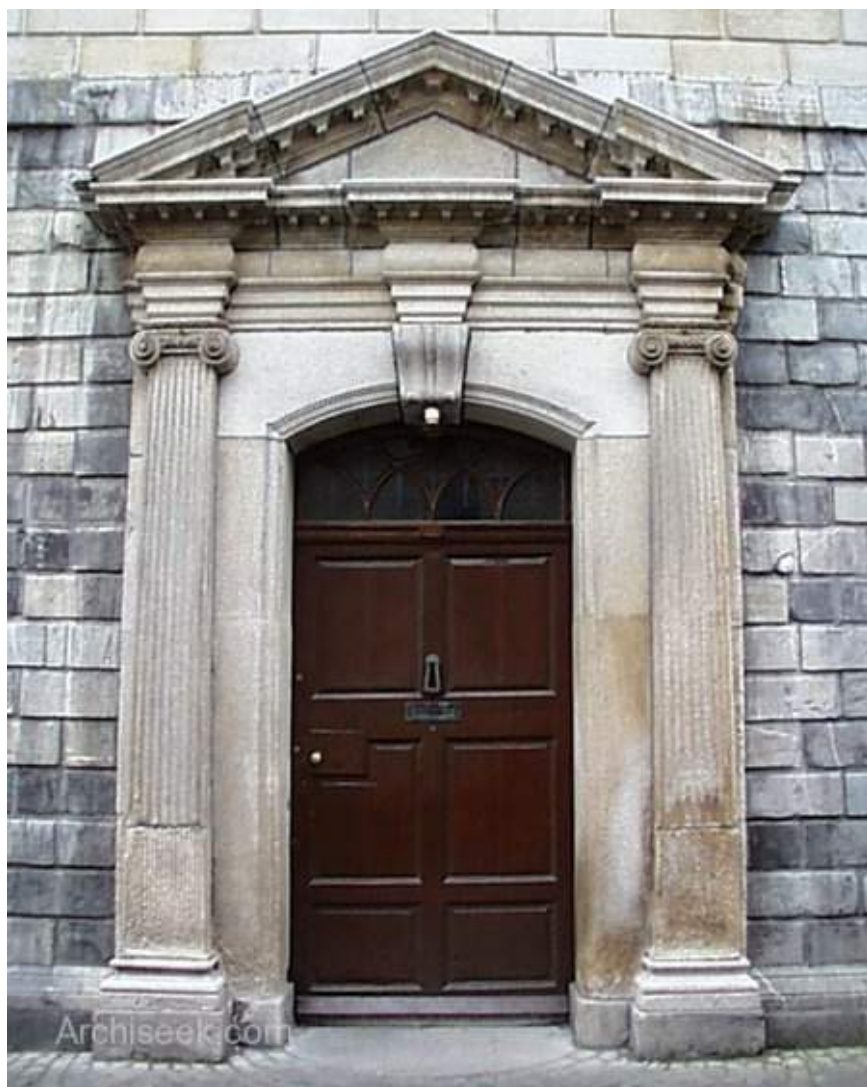
Fig. 3.8. The old library, Trinity College Dublin (1732). The unusually fine ashlar calp rusticated base and a granite doorset.

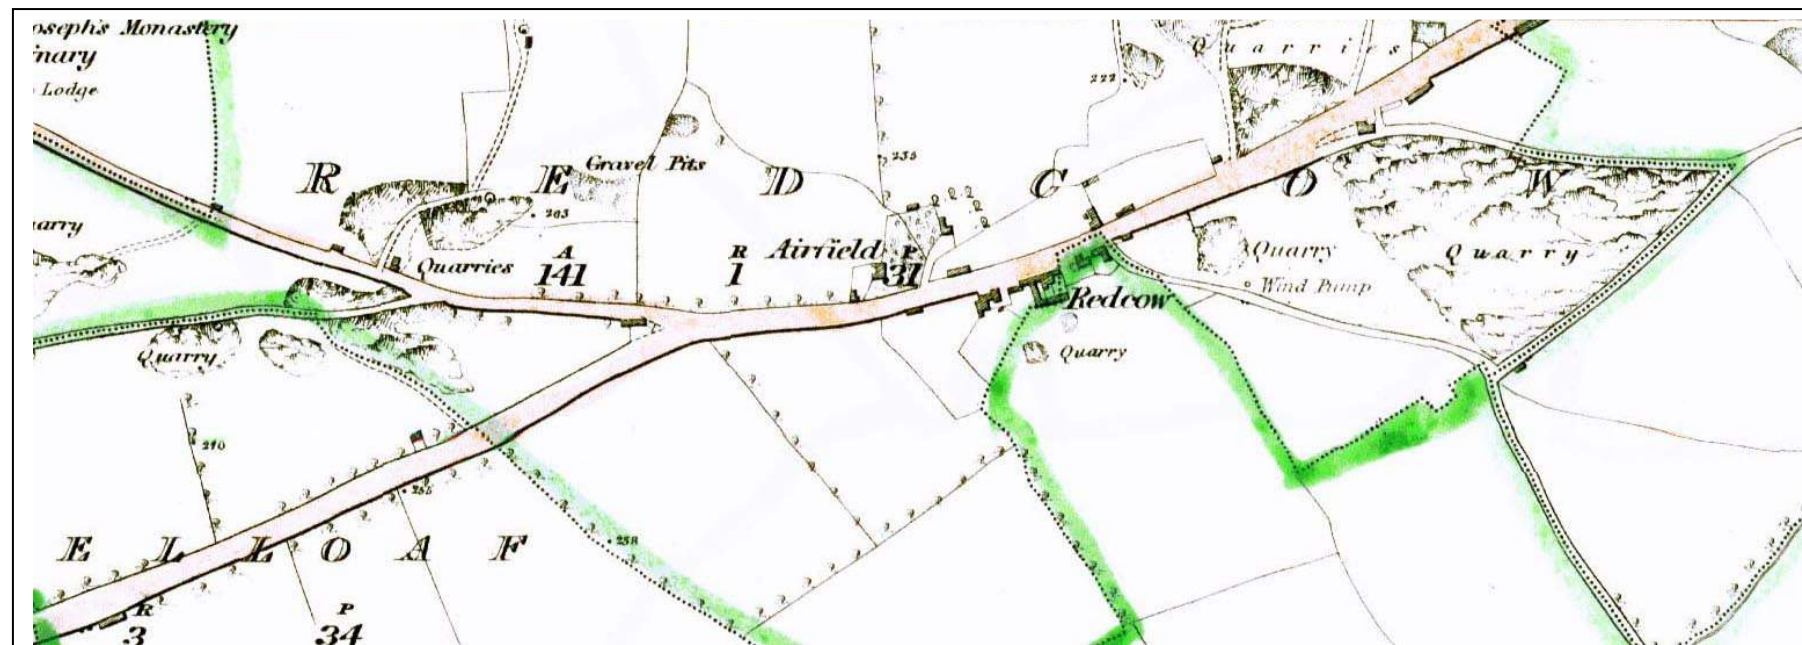
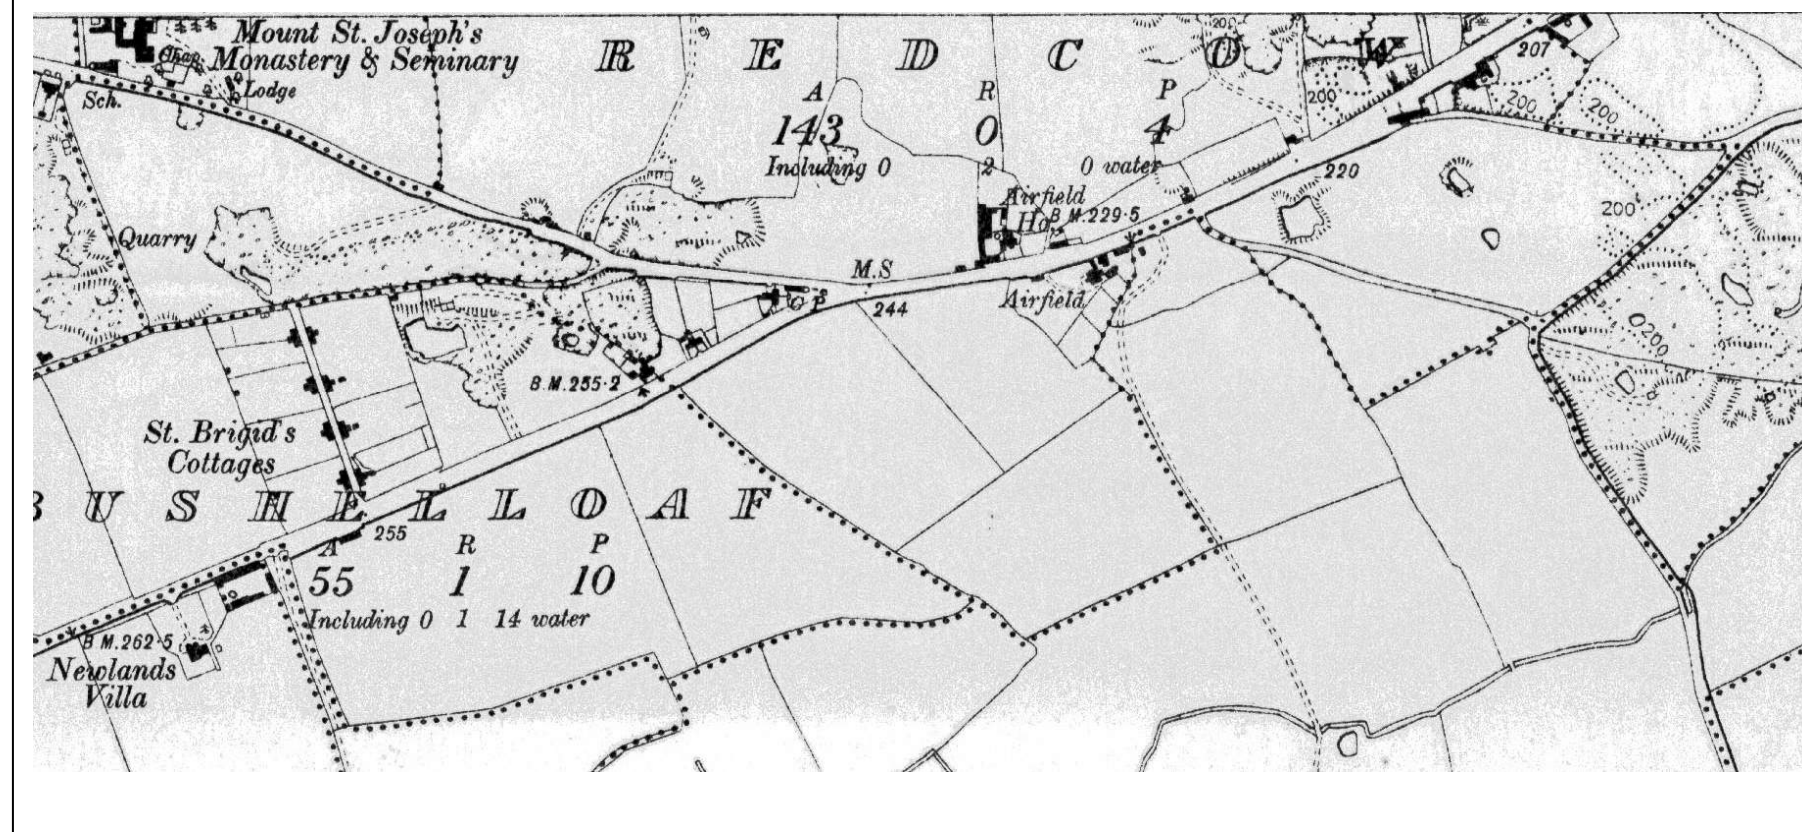
Figure 3.9. Extracts from the 1<sup>st</sup> edition Ordnance Survey (Sheet 21, published 1843) and 3<sup>rd</sup> edition (Sheet No. 21, published 1911) which show the Knockmeenagh Lane area to the south-east of Clondalkin village. The extent and number of quarries and gravel pits is evident. Both Rocque's map (1760) and Duncan's map (1821) show quarries at the end of the lane. Duncan's map describes "Quarries" further east, just beyond Red Cow and Turnpike.

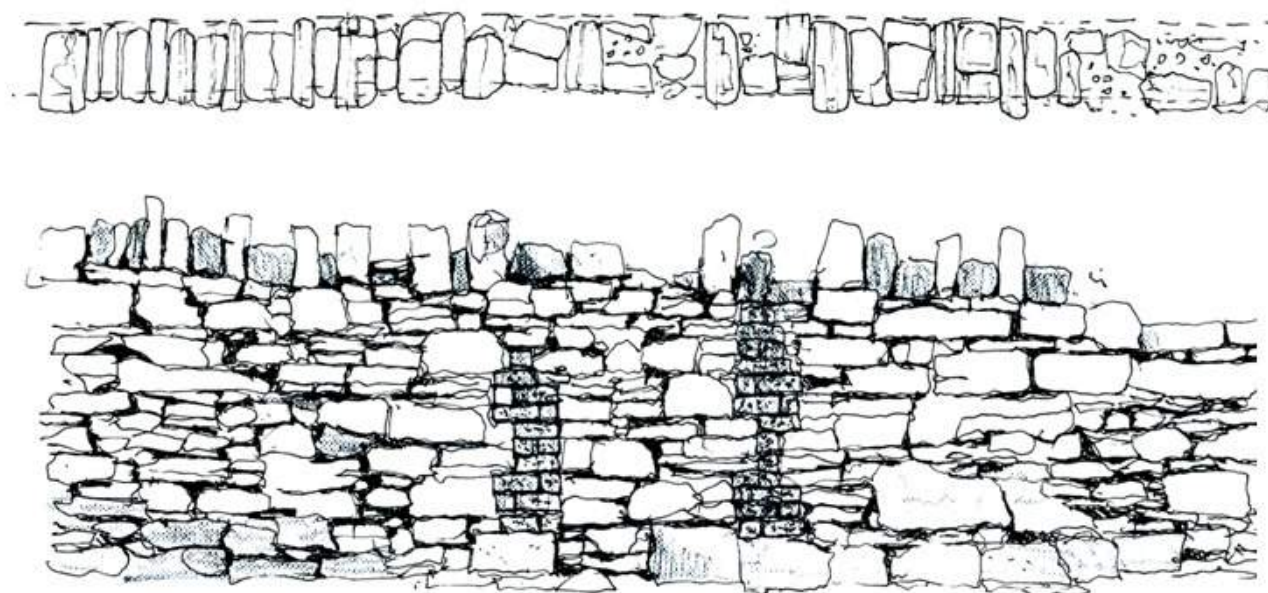
A. Tower Road, east side, outside the old school. Coursed random rubble with massive coping. The wall was built in the late nineteenth century and has been reduced in height since. The wall is clearly shown in the famous Livingstone / Fr. Browne photograph

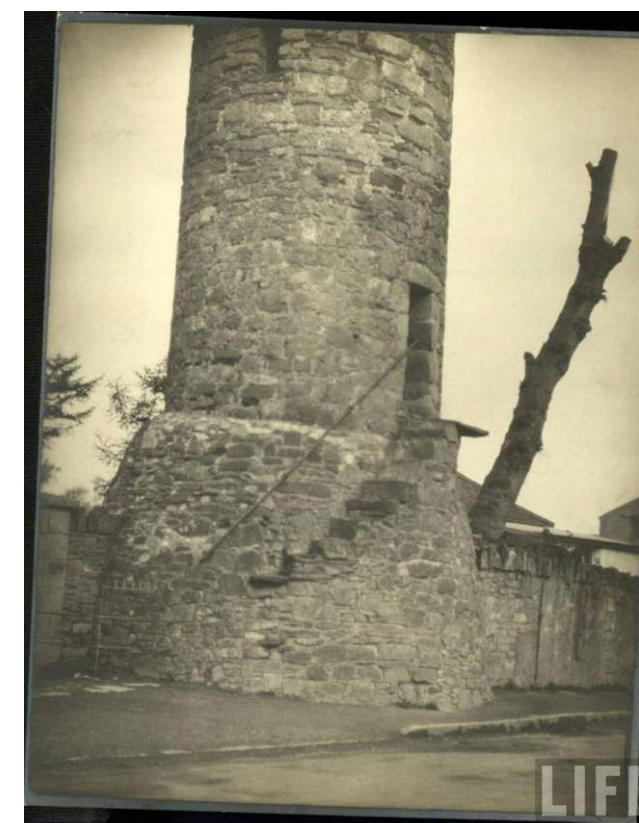
Fig. 3.14. A photograph of the base of the tower, not dated. Note the stub of wall to the north of the tower and the pier of the gate to the south of the tower. (Source: Image donated courtesy of Peter Ging, architect)

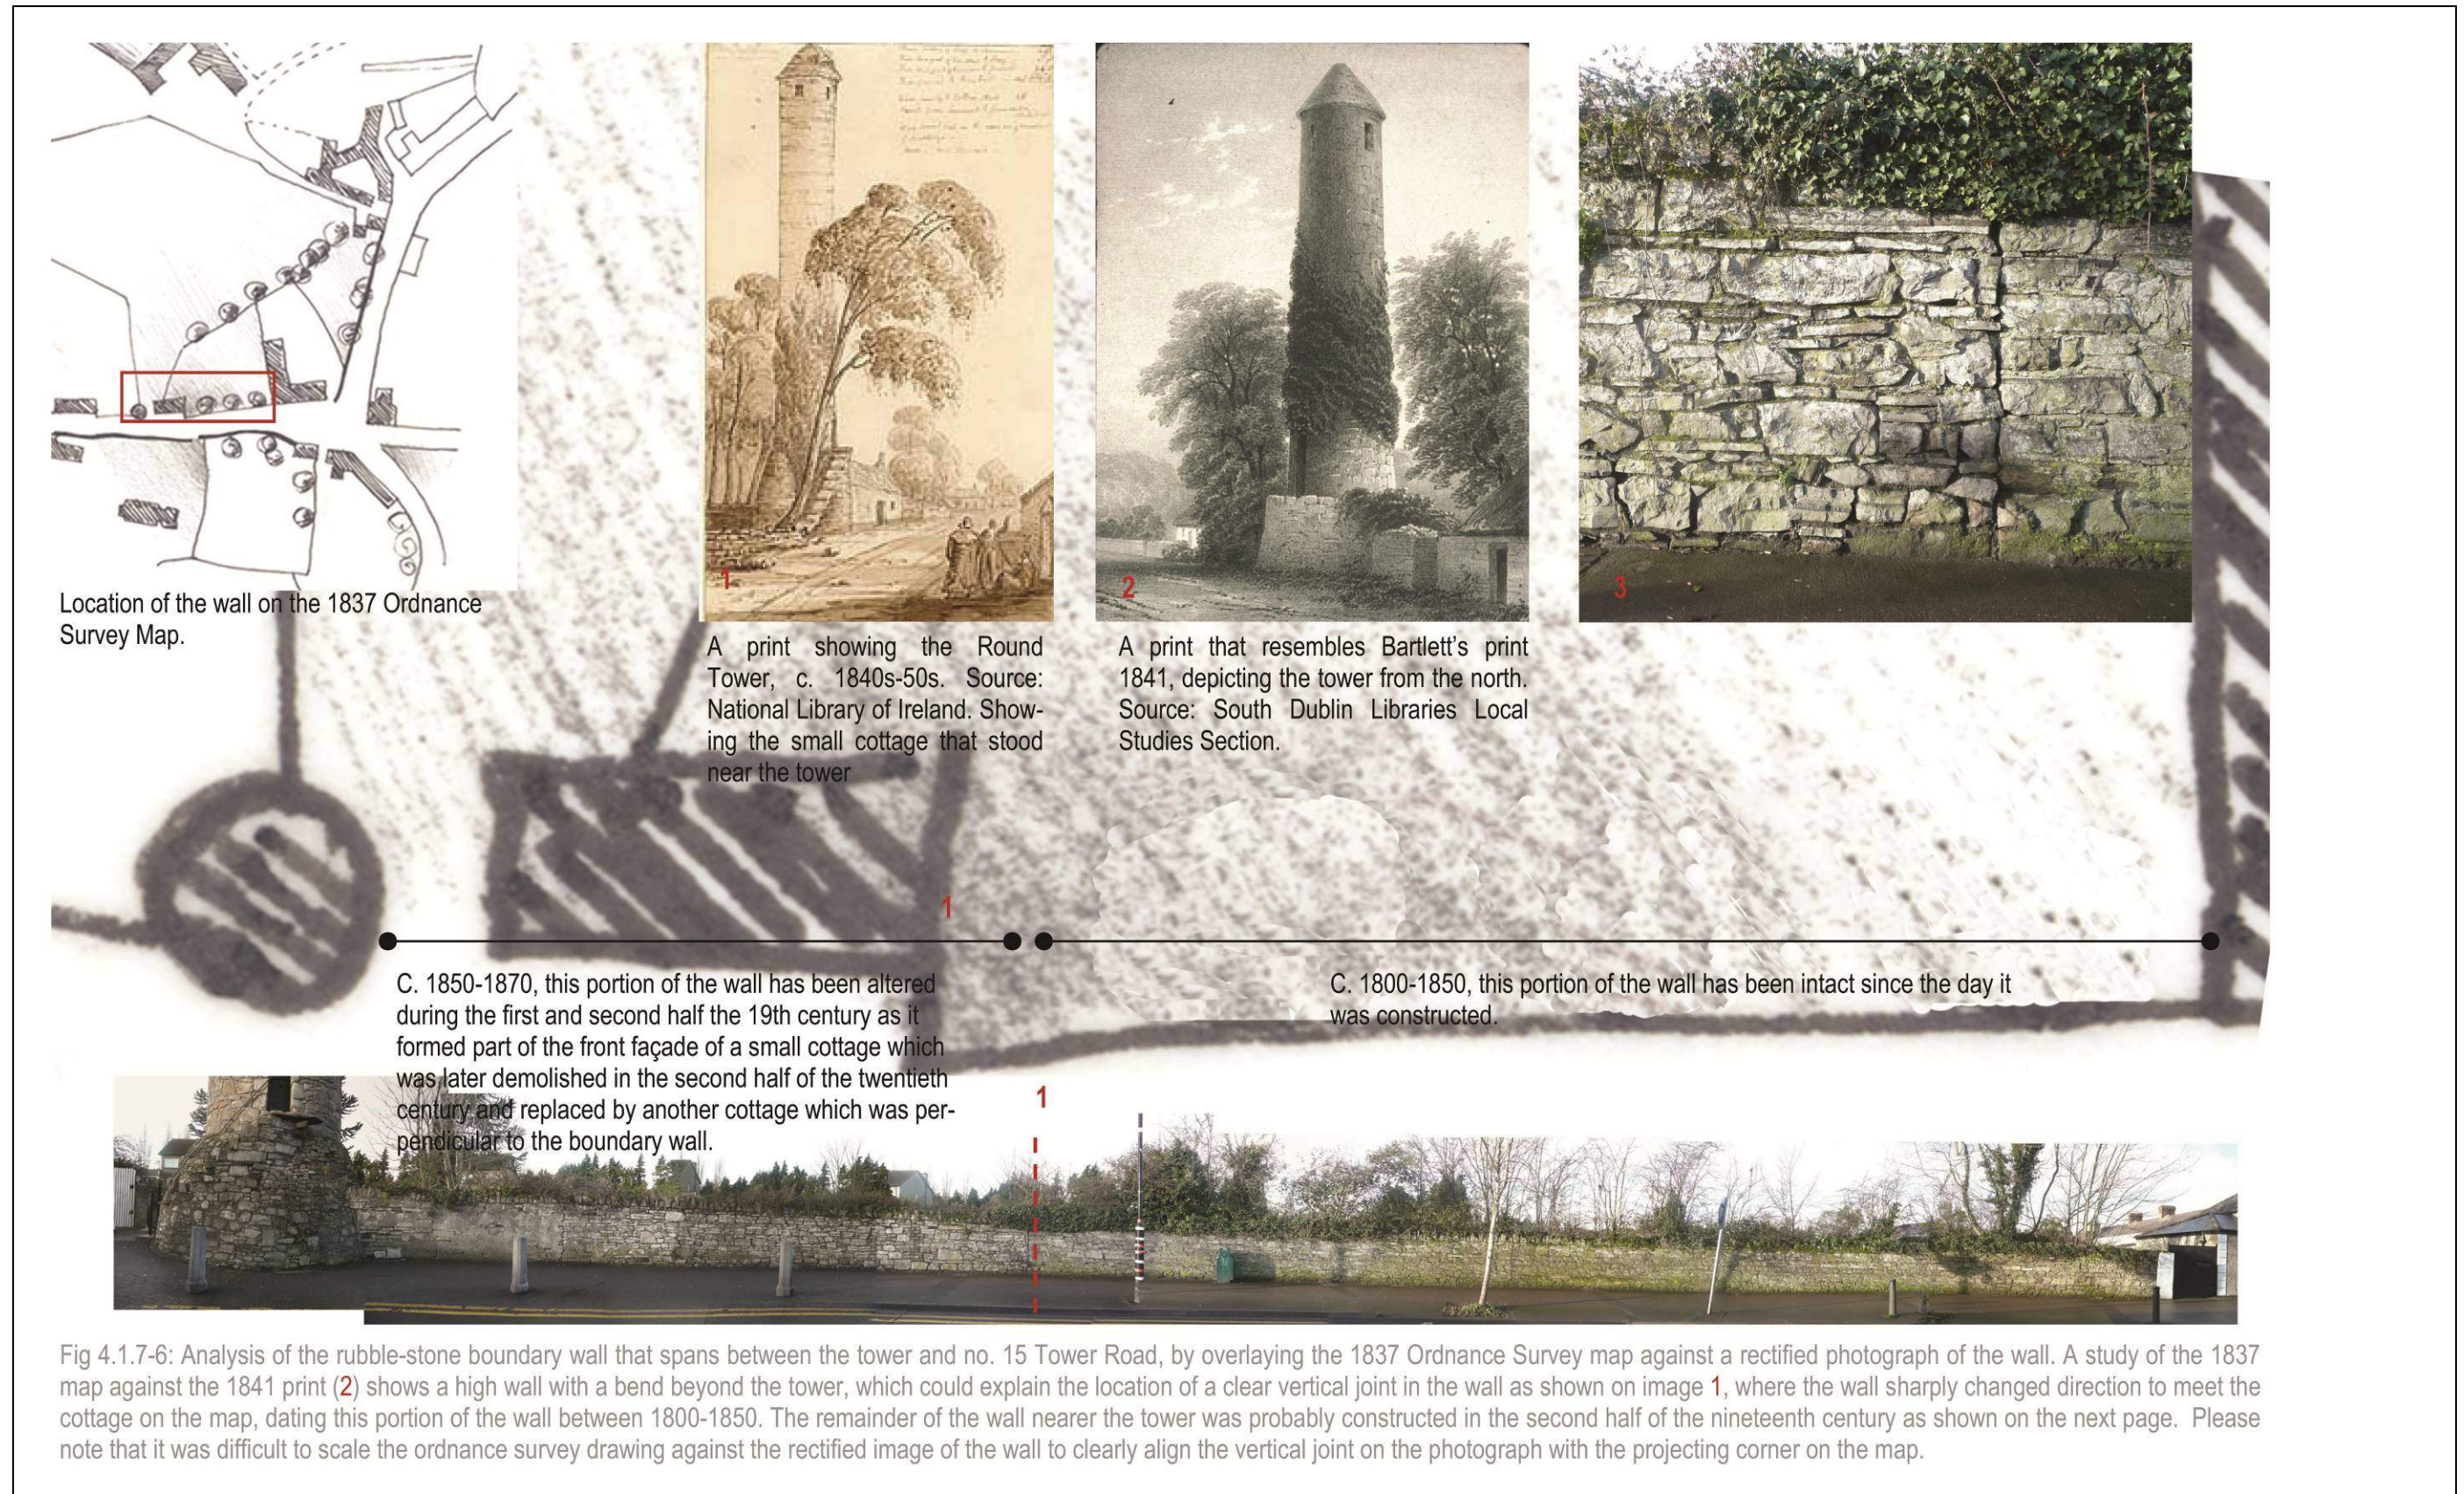
Fig. 3.19. An extract from page 40 of the report "Round Tower Site, Clondalkin – Design and Conservation Report" "commissioned by South Dublin County Council from Shaffrey Associates, Architects (2008). The southern half of the wall nearer to the round tower was probably constructed in the second half of the nineteenth century as part of the boundary to Moyle Park House. However it incorporated some much older wall and building fabric as noted above.

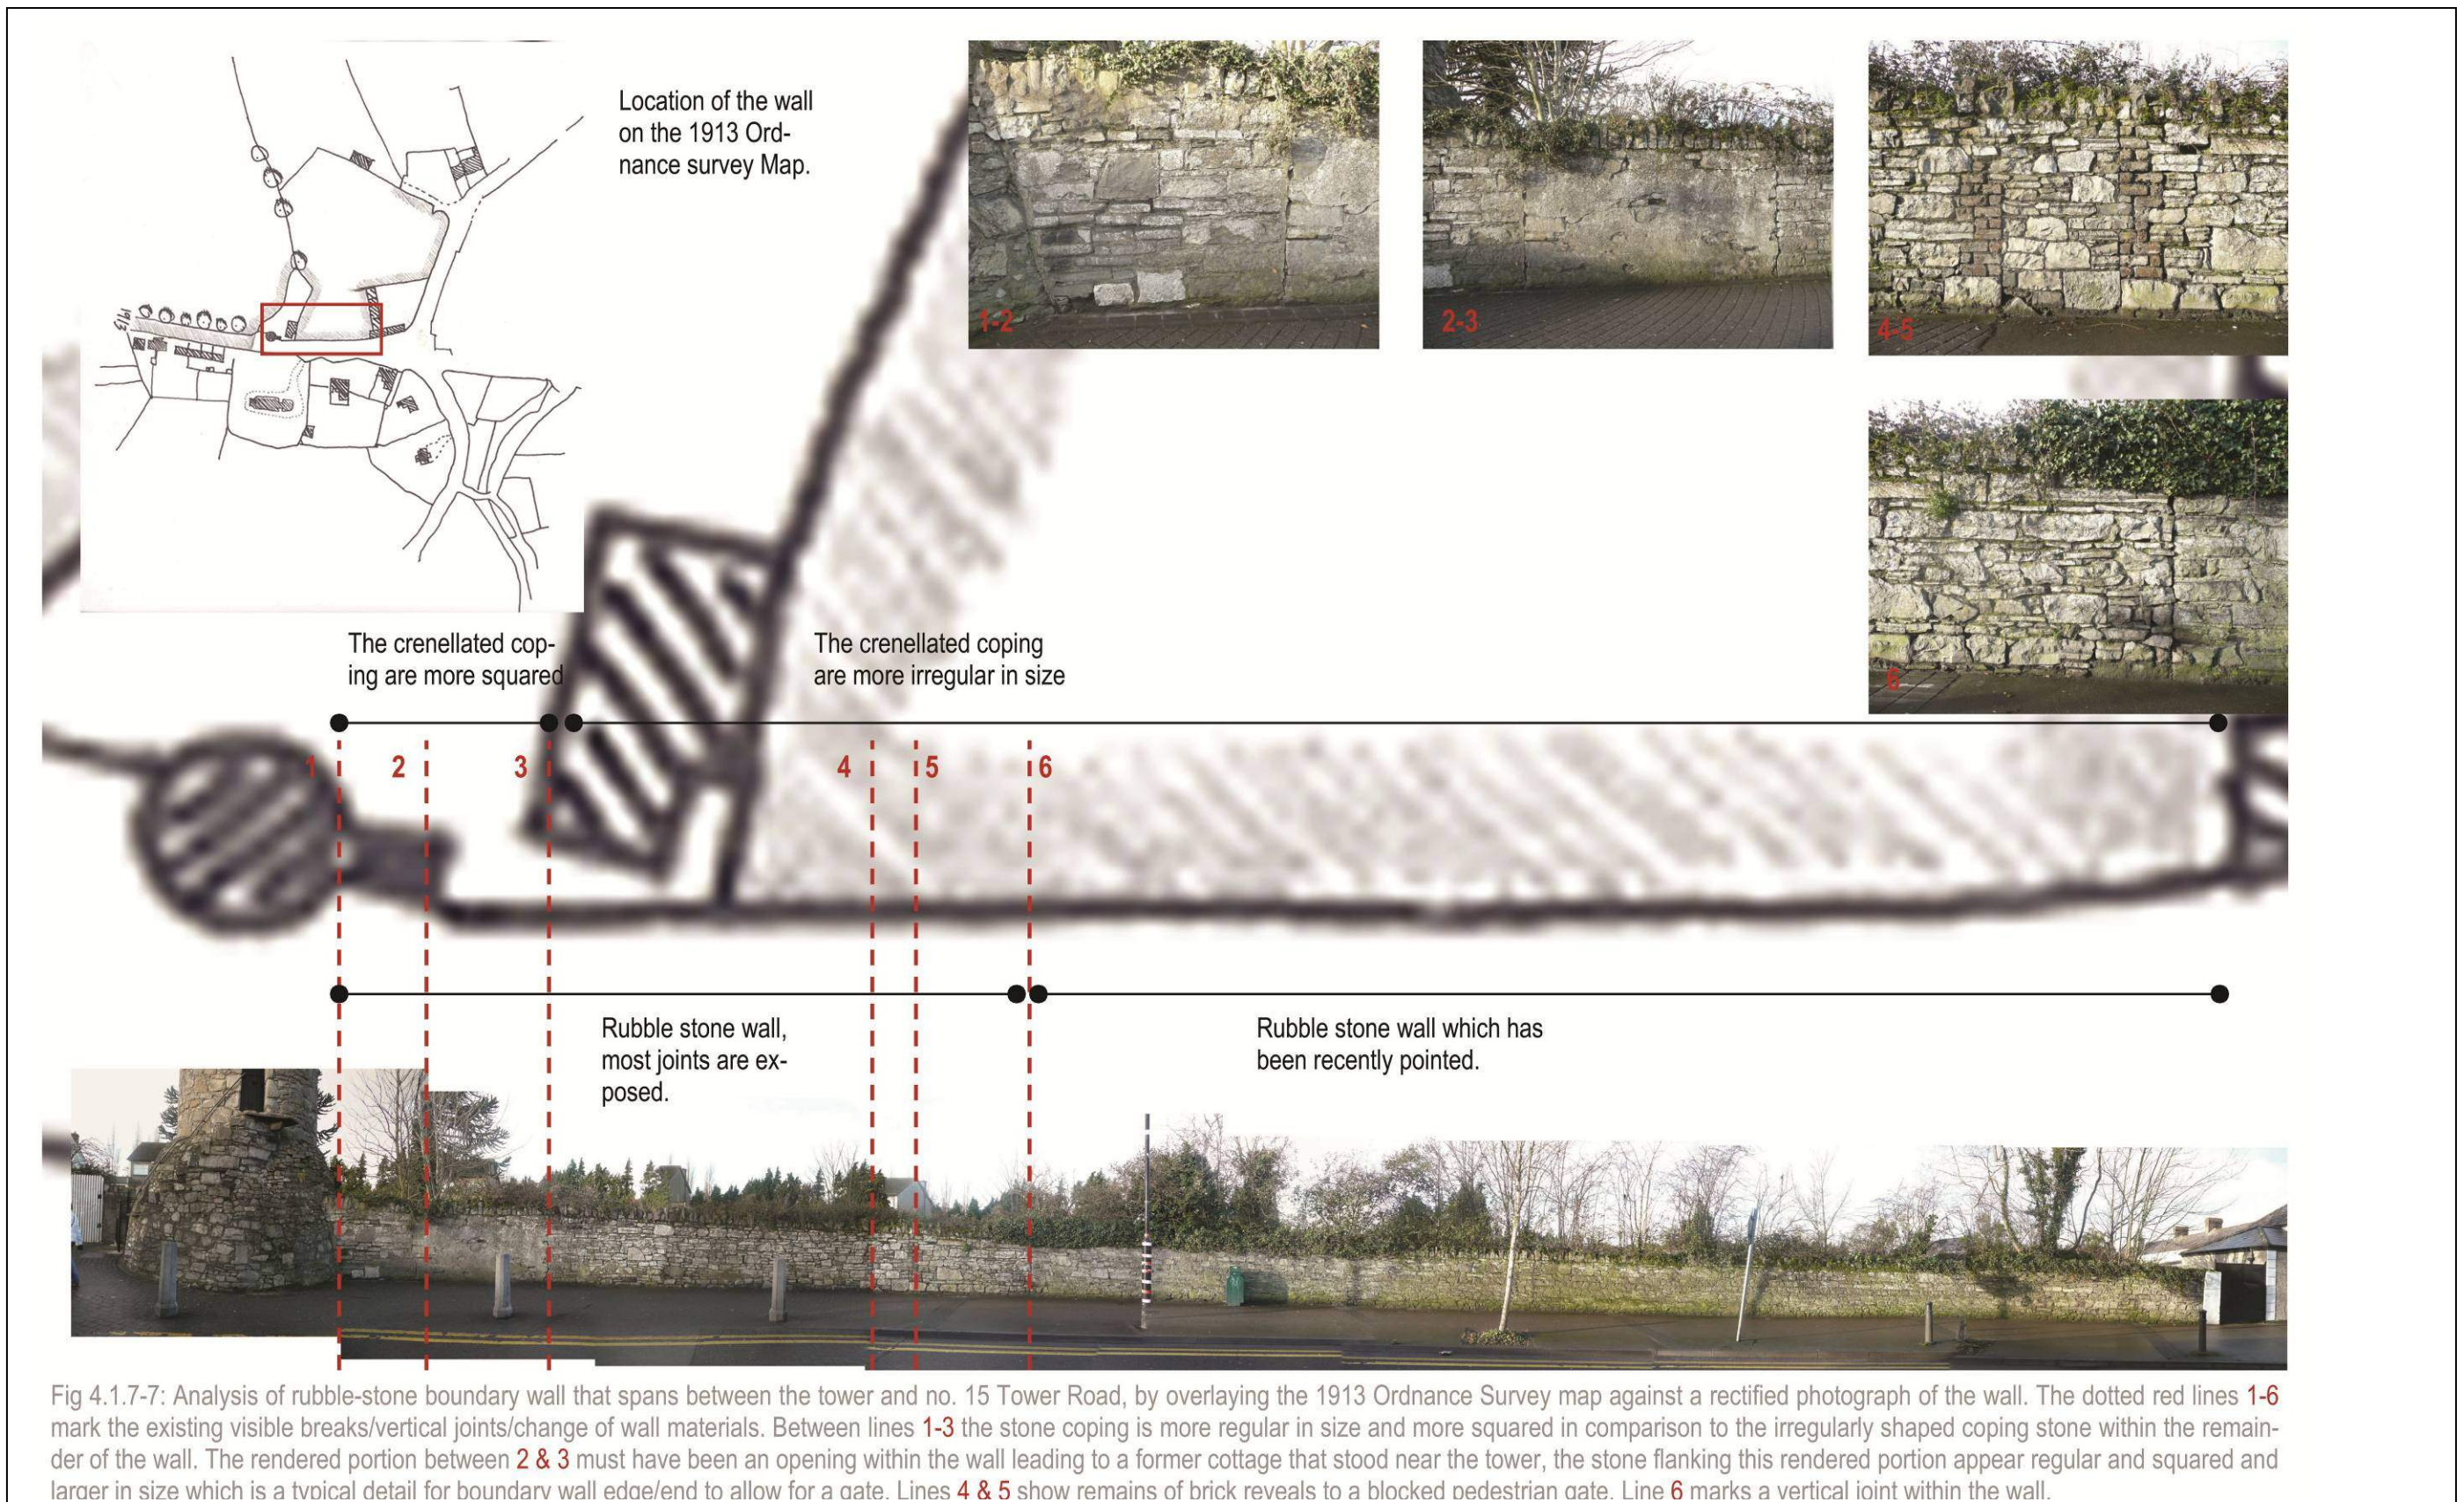
Fig. 3.20. An extract from page 41 of the report "Round Tower Site, Clondalkin – Design and Conservation Report" "commissioned by South Dublin County Council from Shaffrey Associates, Architects (January 2009). The northern half of the wall was probably built during the first half of the nineteenth century – the section which is to the right of the clean vertical joint on image 6 above. It is more consistent in construction with fewer breaks and vertical joints.

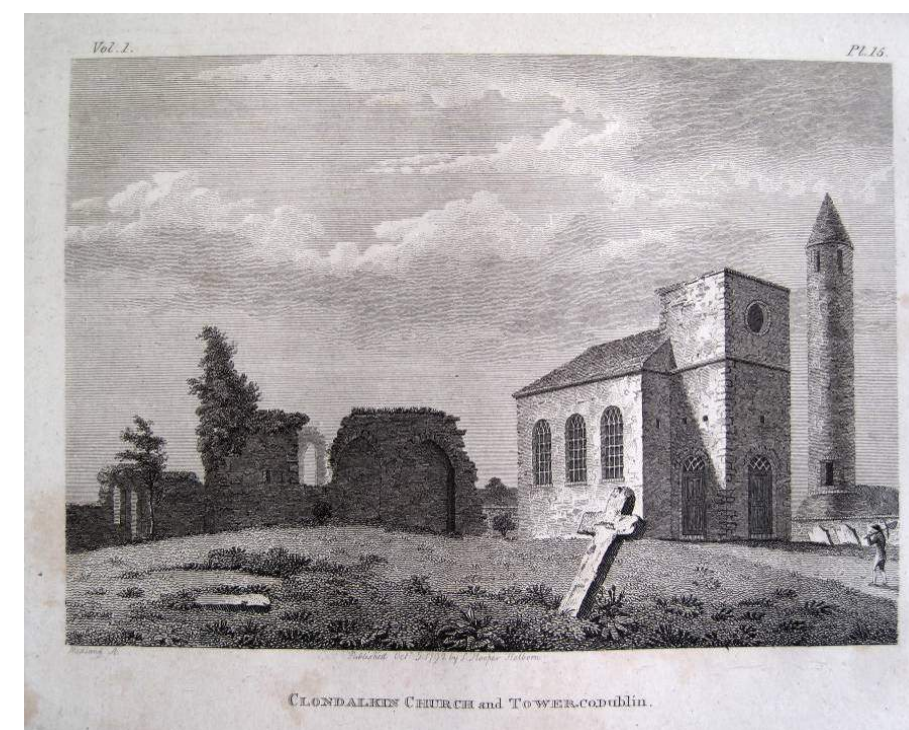
Fig. 4.23. "Clondalkin Church and Tower, 1791" from Grose's Antiquities. The older church is already a ruin beside and behind the then recently built new church of St. John. Although the condition of the older church had deteriorated during the eighteenth century it was badly damaged by the gunpowder explosion at Corkagh in 1787. (Source: South Dublin Libraries, Local Studies Collection)

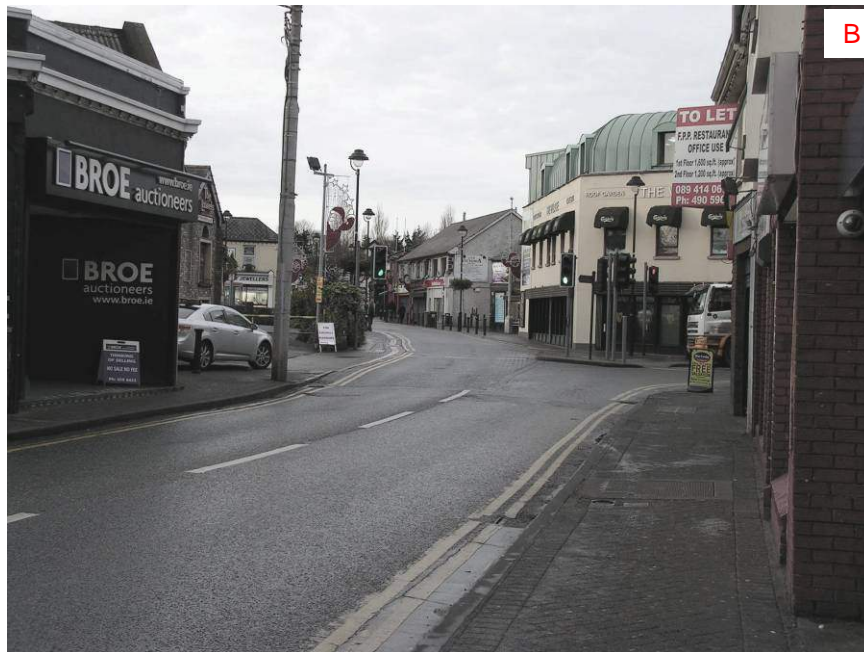
A current view, photographed from the same viewpoint as the Eason photograph opposite. The "Village Inn" is the third generation building on the island site; about 10 years ago it replaced the building shown on the Eason photograph opposite. (January 2013)

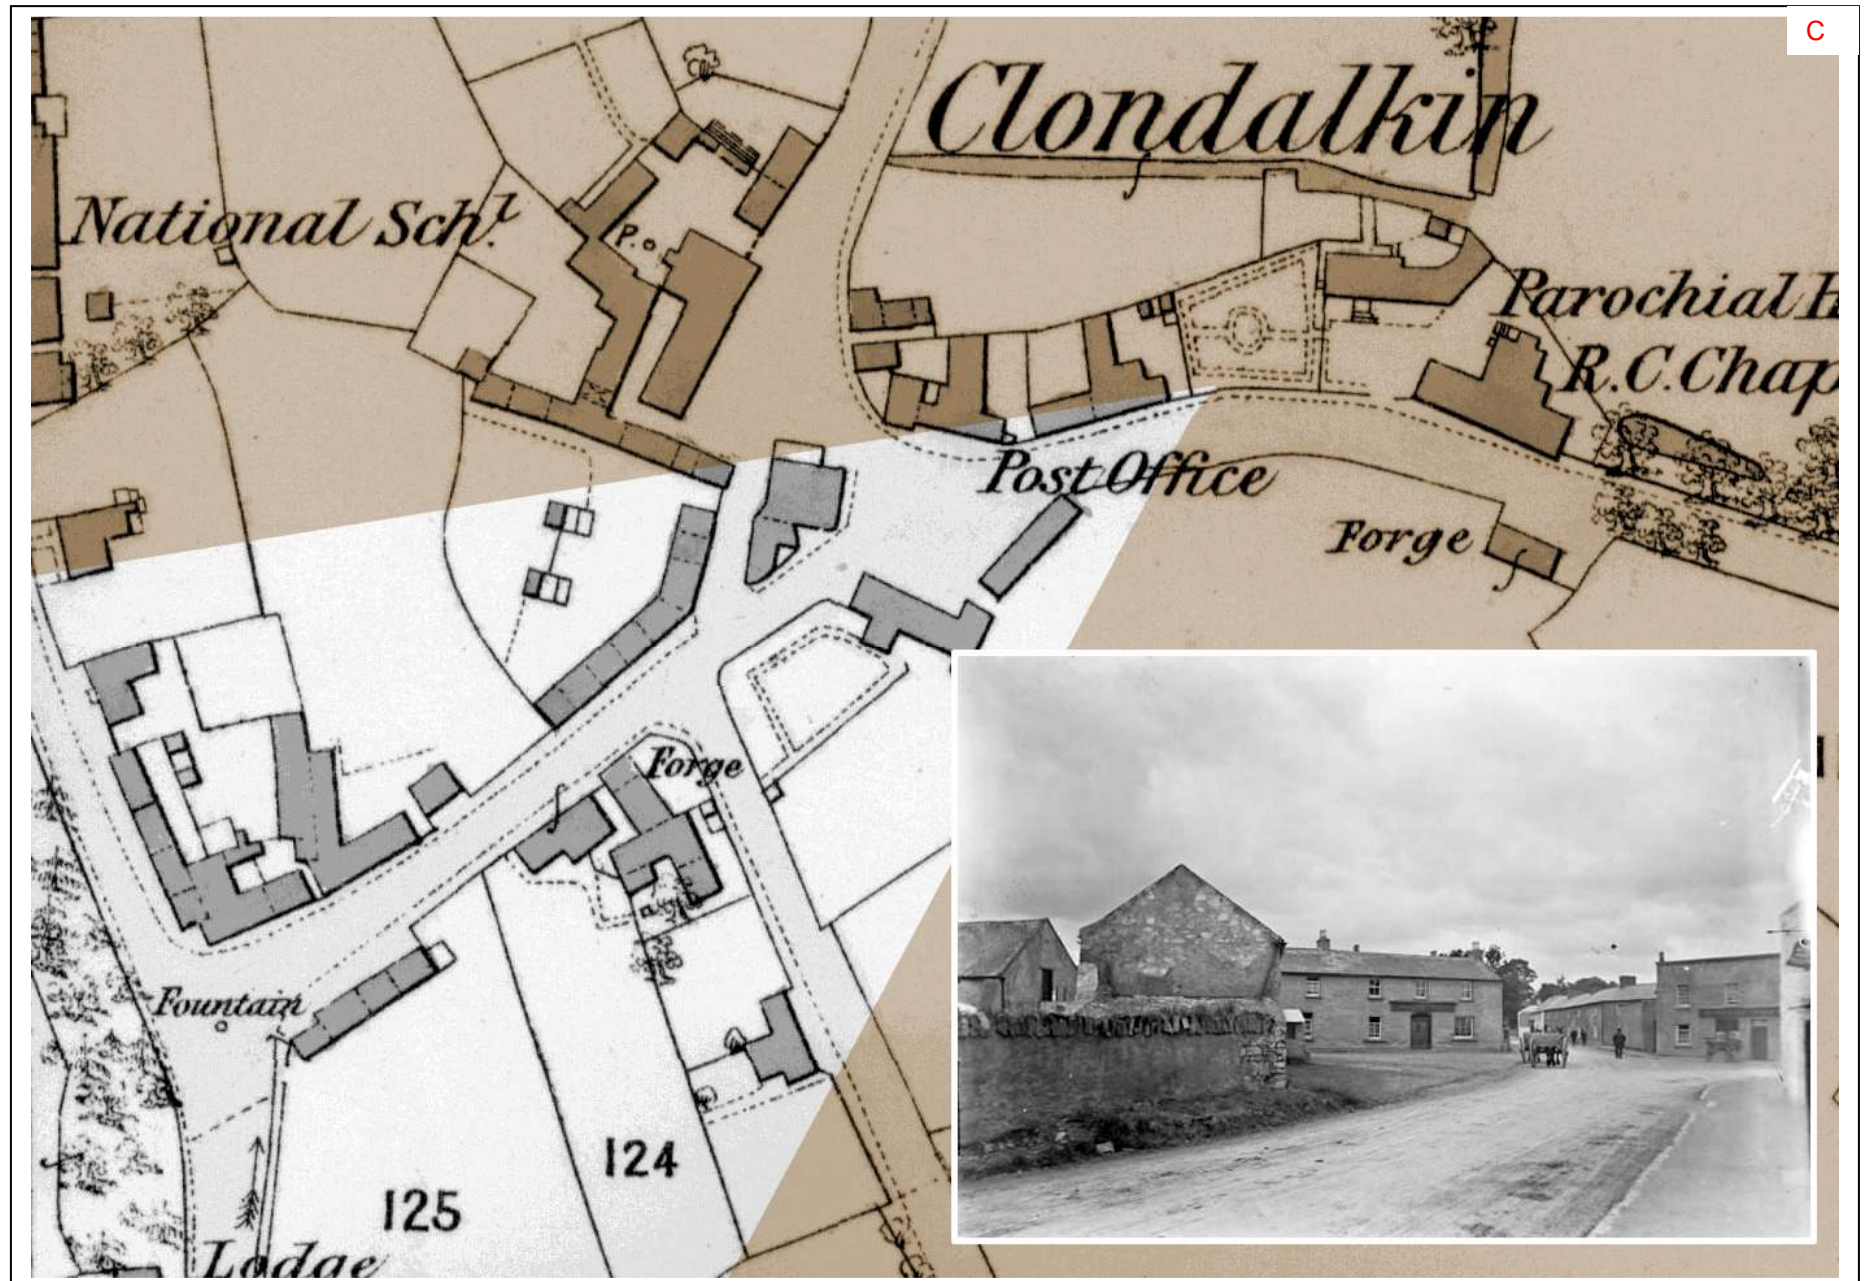
Figures 4.62, A, B & C. Three views of the former market place at the junction of Monastery Road, Orchard Road and Main Street. Three generations of building occupying the island site in the centre of the market place are shown.

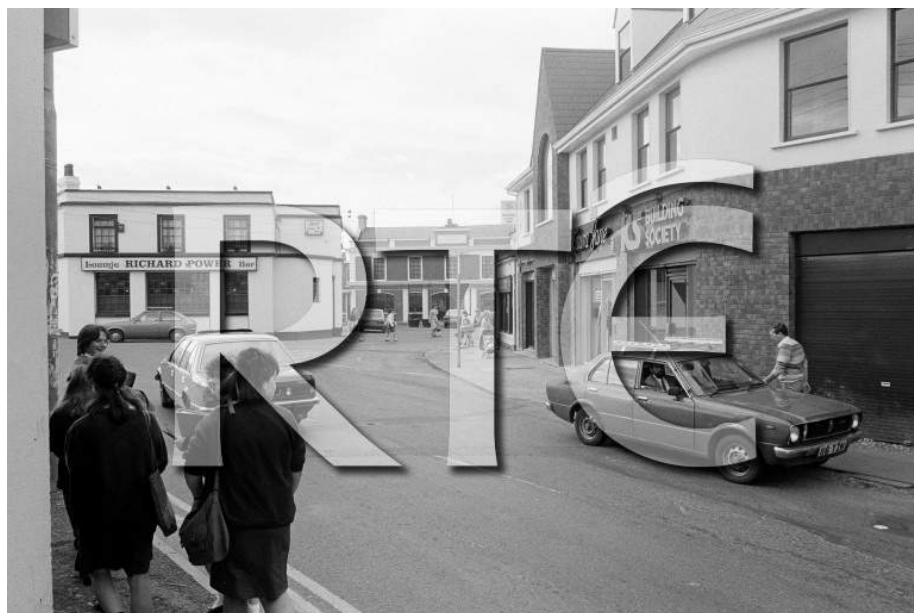
Fig. 4.63. A photograph of the east side of Richard Power's pub (now the "Village Inn") from the end of Monastery Road, taken in 1989. Compare this with the early twentieth century view in the Eason print on the previous page. (Source RTE stills library, from the website <https://stillslibrary.rte.ie>)

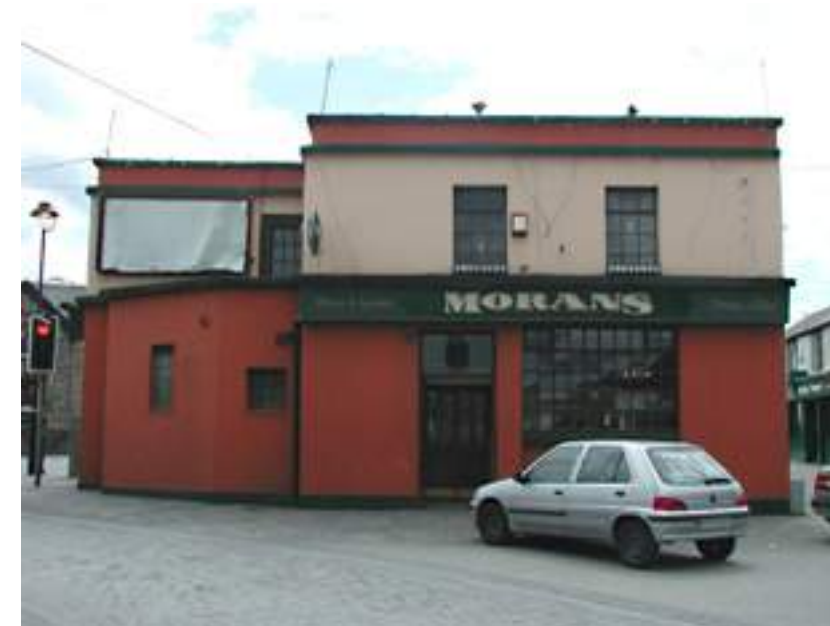
Fig. 4.68. The north façade of the same building which faced Orchard Lane, photographed in 2002, since demolished and replaced by the "Village Inn". The National Inventory of Architectural Heritage (N.I.A.H.) dates this building to about 1850. Therefore the watercolour in Fig. 4.62A on the previous page shows the building which pre-dated this public house. (Source: the website of the N.I.A.H., [www.buildingsofireland.ie](http://www.buildingsofireland.ie))

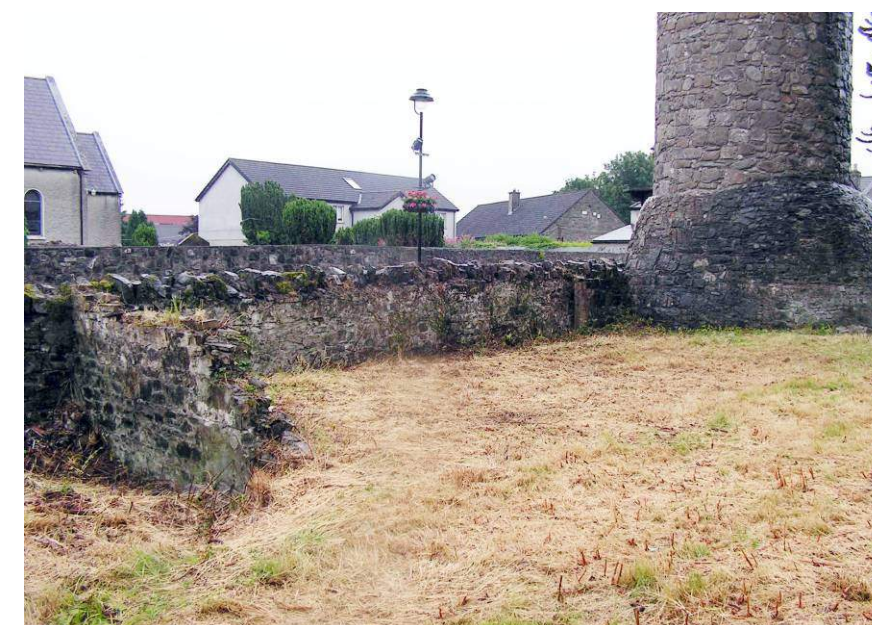
Fig. 4.69. A photograph of the boundary wall to the north of the round tower. Note the two stubs of wall immediately to the north of the tower and the remains of a boundary wall in the left foreground (June 2013)
