Architectural  
Services  
Department

## **CLONDALKIN ROUND TOWER VISITORS' CENTRE**

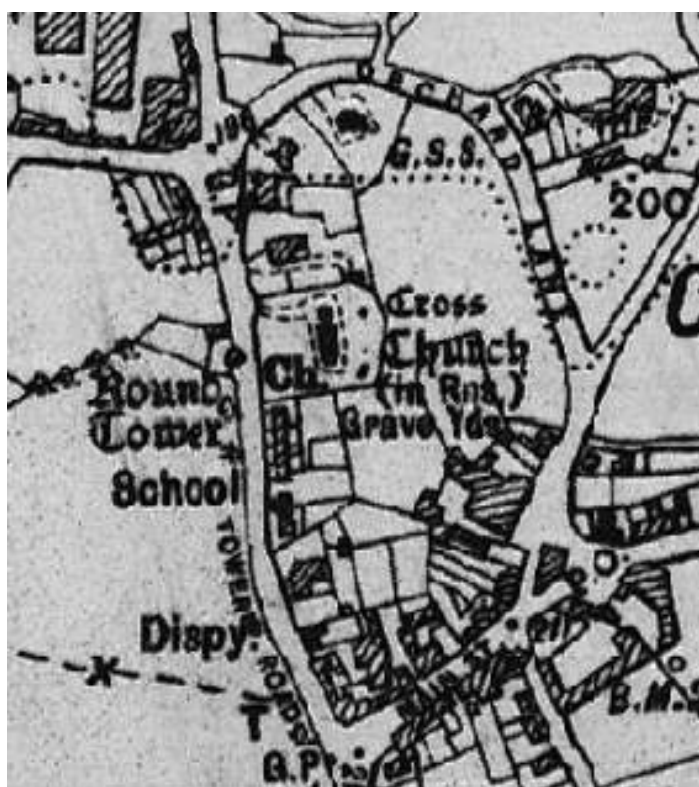
Fig. 4.78. The fourth edition (circa 1935-38). The 4th edition map shows that a boundary wall, fence or hedge once existed behind number 16 and contained a very narrow long strip of garden or yard behind the house which connected with the existing yard at the north end of the house. (Source: South Dublin Libraries, Local Studies Collection)

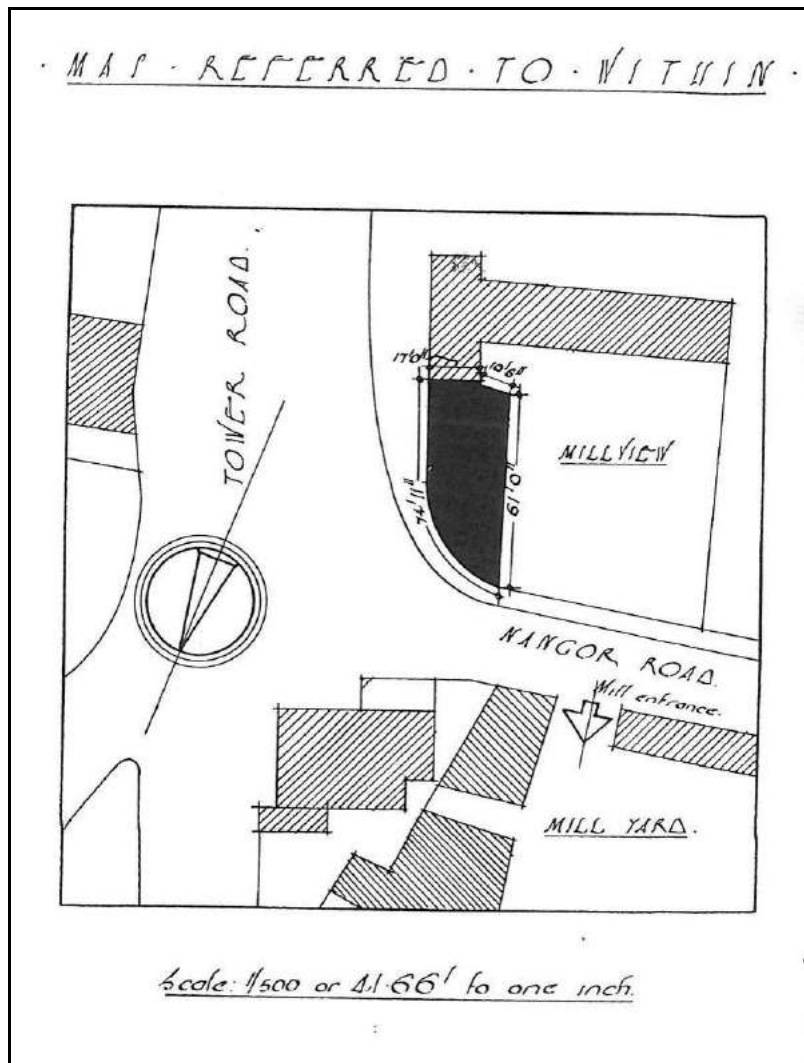
Fig. 4.79. An extract from the indenture for 16 Tower Road which was part of the deeds prepared for the purposes for transfer of ownership or acquisition of lands. The drawing shows the layout and dimensions of the site of the house and the former back yard. This layout accords with that shown 1969 ordnance survey map shown below. The layout is also interesting because it shows that the extension of number 28b Roundtower Road back into Millview Terrace appears to line up with the former party wall between 28b Roundtower Road and 5e Millview. (Source: South Dublin County Council's records of the Development Department)

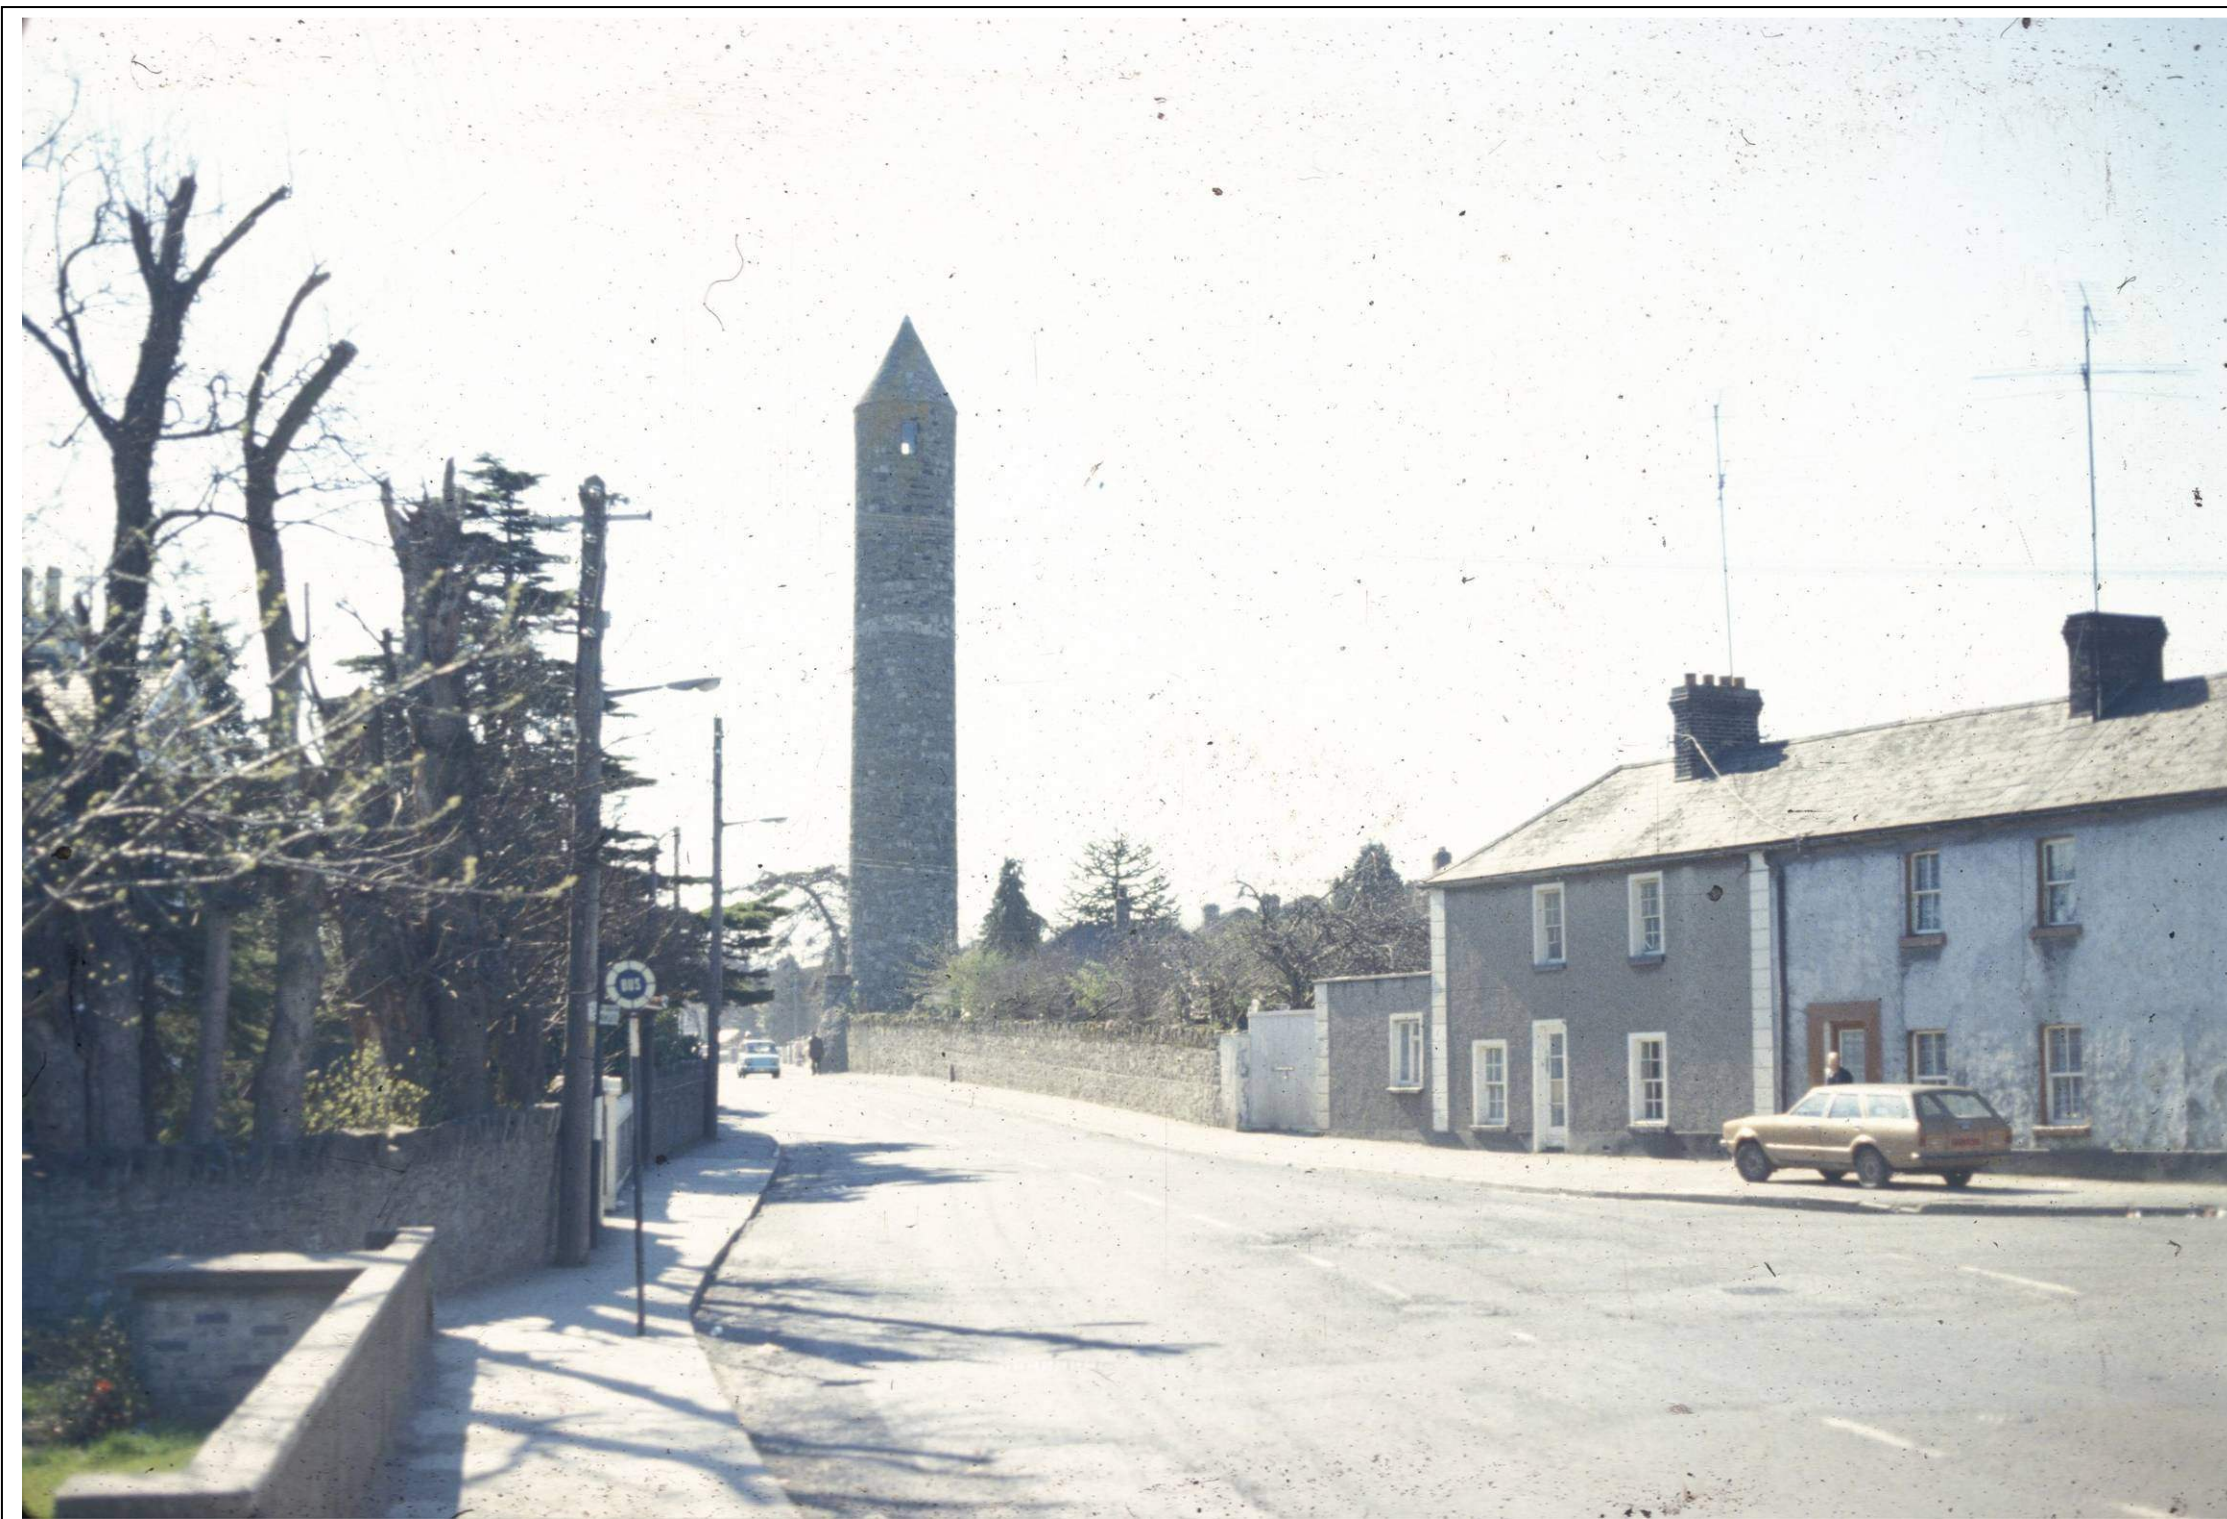
D (main image above): From the cars in the photograph, this view probably dates from the 1970's. The photo is overlaid on the 1969 Ordnance Survey map. (Source: South Dublin Libraries, Local Studies Collection)

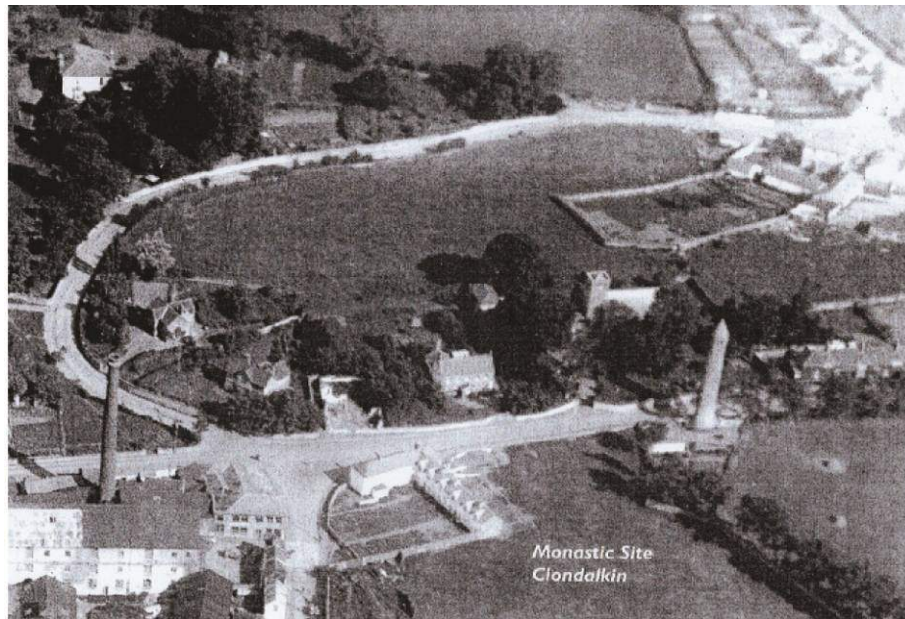
Fig. 4.86. An aerial postcard view of the site. The boundary running east west across the field to the north of the tower is now just a step down in the long grass. The irregular elongated back gardens of Millview Terrace have not yet extended down the field. (Source: page 35 of "Round Tower Site, Clondalkin-Design and Conservation Report" by Shaffrey Associates Architects for South Dublin County Council").

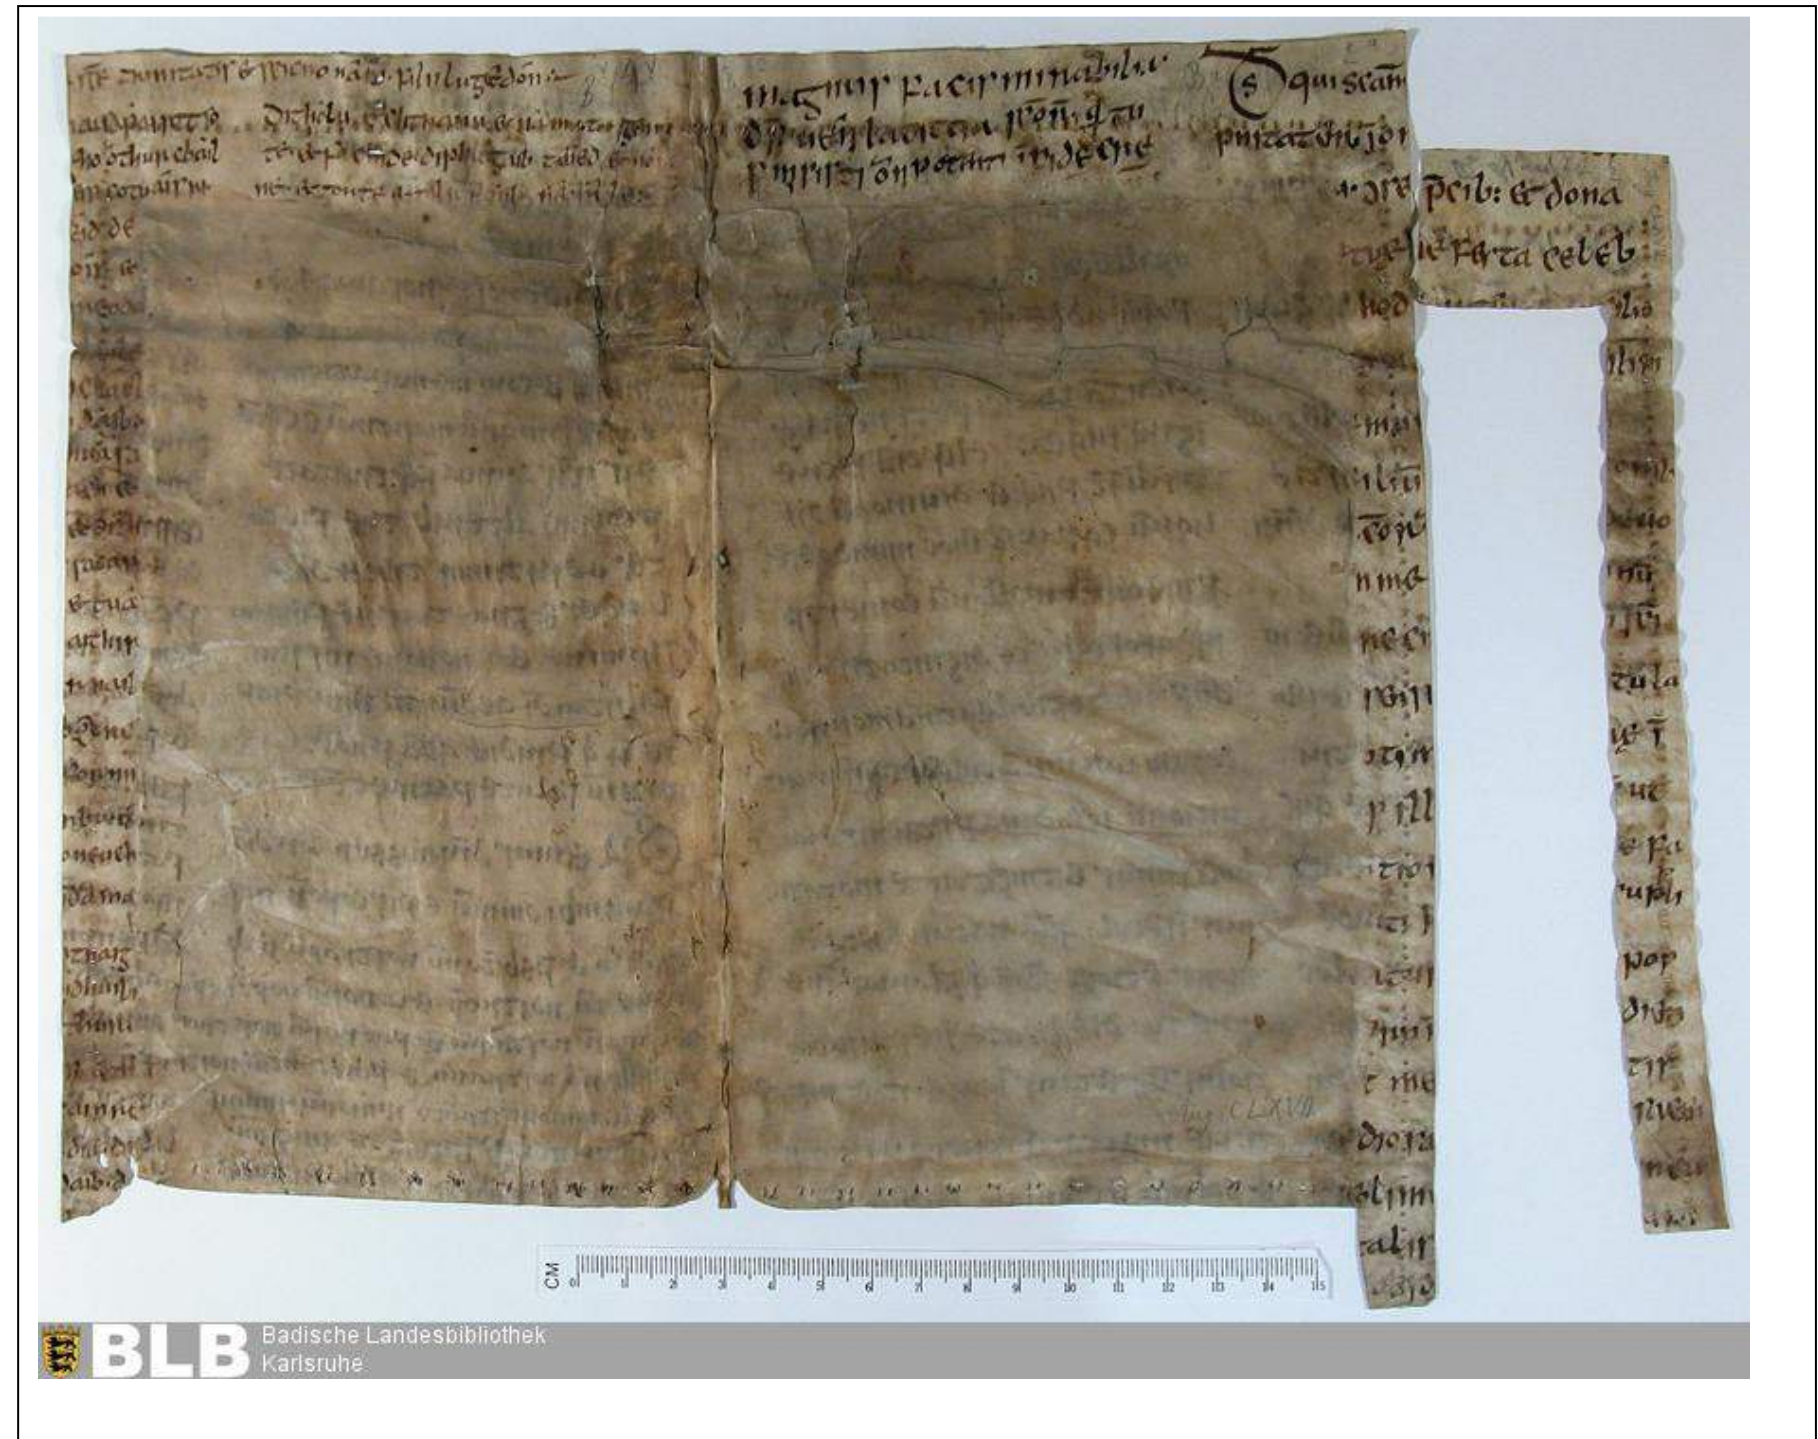
Figure 5.1. A diagram of the distribution of centres of Irish influenced settlements around Europe during the early Christian period. (Source: page 26 of “Guide to the Irish National Heritage Park, Ferrycarrig, Wexford”, by Edward Culleton, B.A., Ph.D., 1987, The Wexford heritage Trust, 1990, first published 1987)

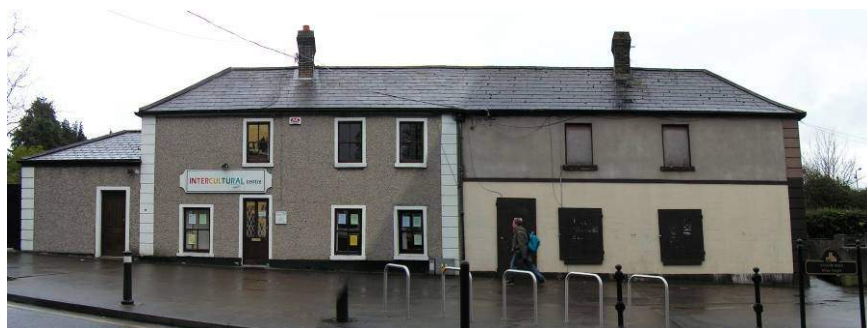
Fig. 6.1. Numbers 15 and 16 Tower Road, viewed from Tower Road (January 2013)

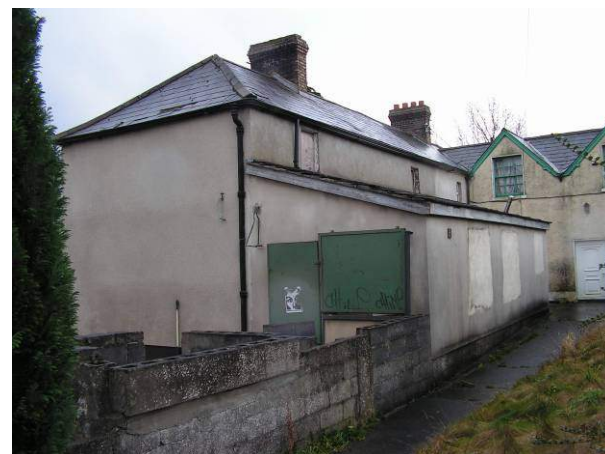
Fig. 6.3. The extension to 16 Tower Road which occupies most of the former yard space of number 16, as shown in the 1969 ordnance survey map (Figs.4.84D, pg. 65 and 4.78, pg. 62). (January 2013)

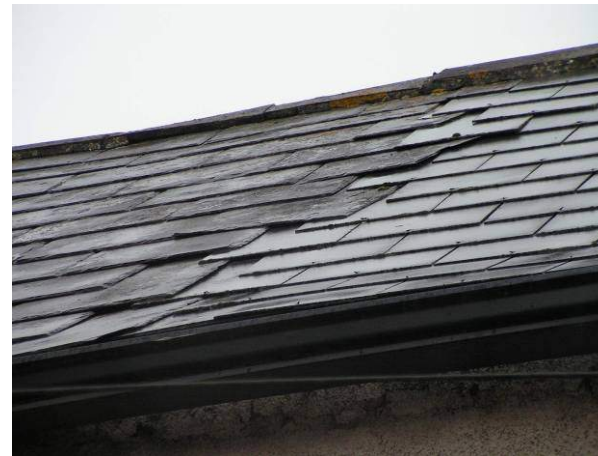
Fig. 6.11. Slipped and missing slates at the junction of the natural slates above number 16 and artificial slates of number 15. (January 2013)

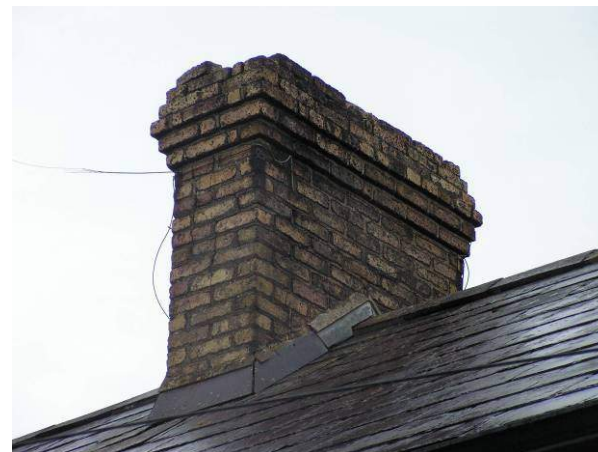
Fig. 6.12. Above 15 and 16 Tower Road. Eroded mortar joints and missing bricks. (January 2013)

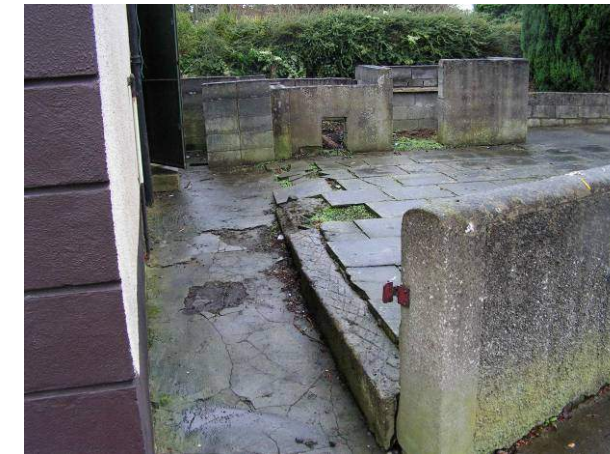
Fig. 6.14. The yard to the north of 16 Tower Road. (January 2013)

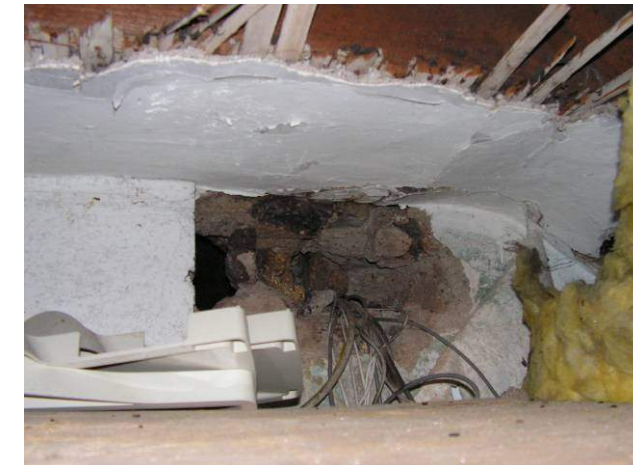
Fig. 6.30. The attic above 15 Tower Road. A fragment of the older plaster and lathe ceiling remains above the modern plasterboard ceiling on the bottom of the photo. The artificial roof slate above has been laid on a bituminous felt.

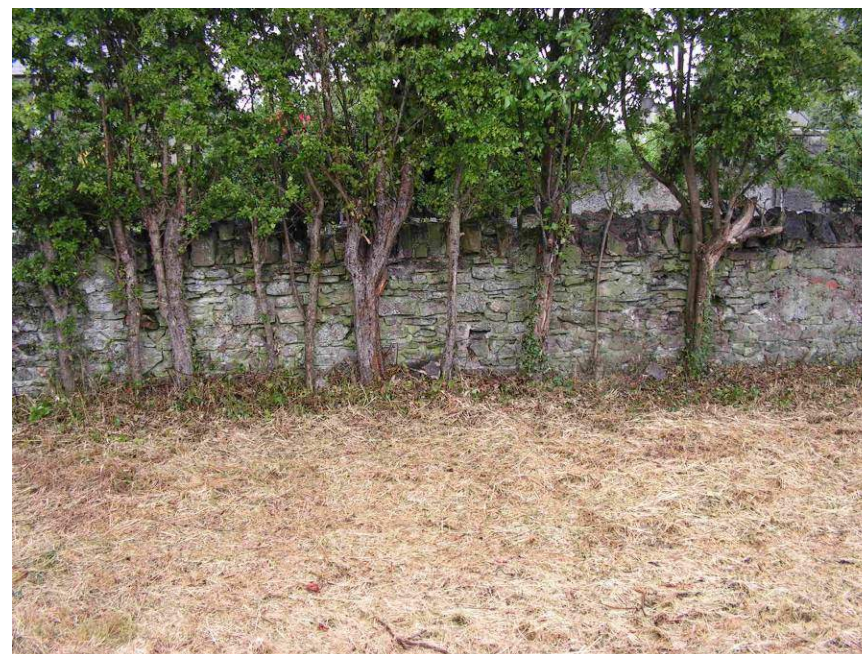
Fig. 7.1. A view of the stone boundary wall along Tower Road from the west side. Note the trees growing right beside the wall. (June 2013)

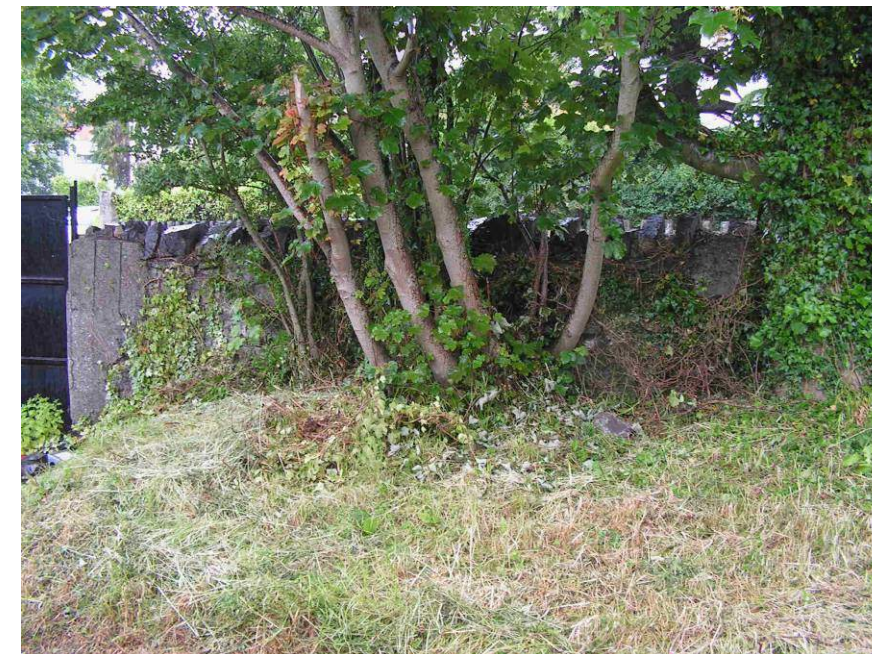
Fig. 7.2. The northern end of the same stone boundary wall along Tower Road, just to the south of the gate beside 15 Tower Road. (June 2013)

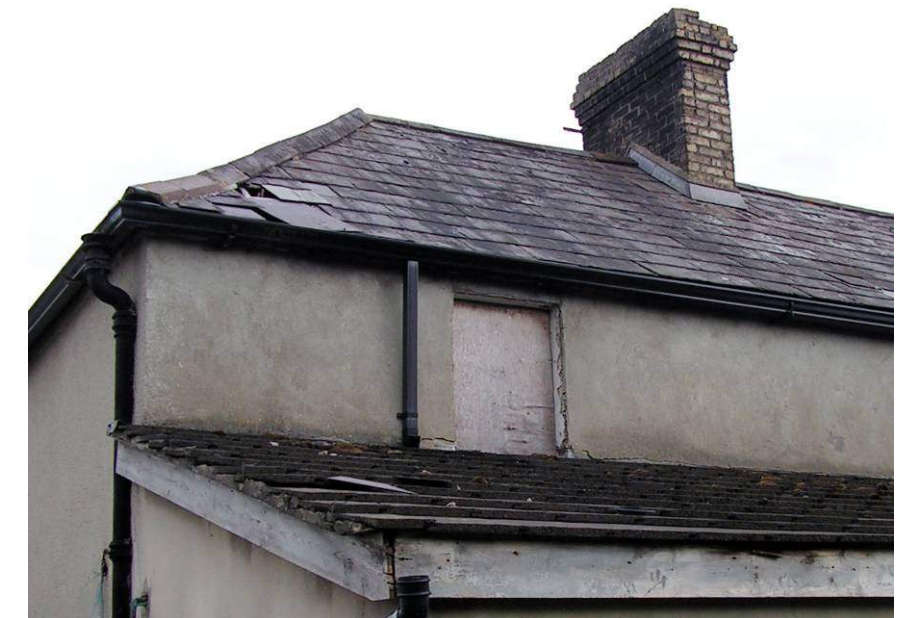
Fig. 7.1. Breaches in the roofs above 16 Tower Road, partly missing gutter, and decay in the fascia and soffit above the extension (May 2013)

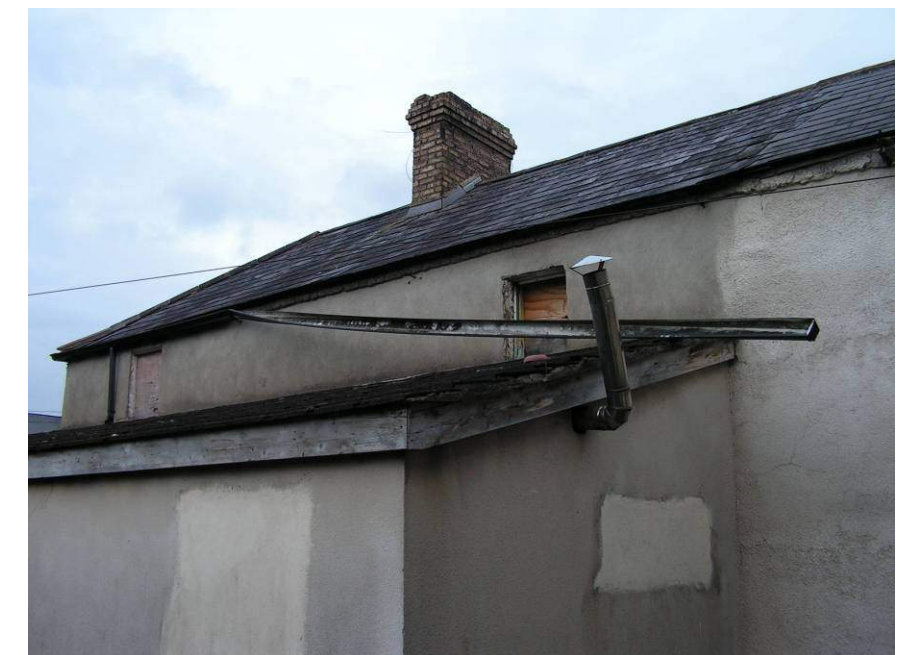
Fig. 7.2. Fallen gutter at the back of 16 Tower Road. (November 2013)

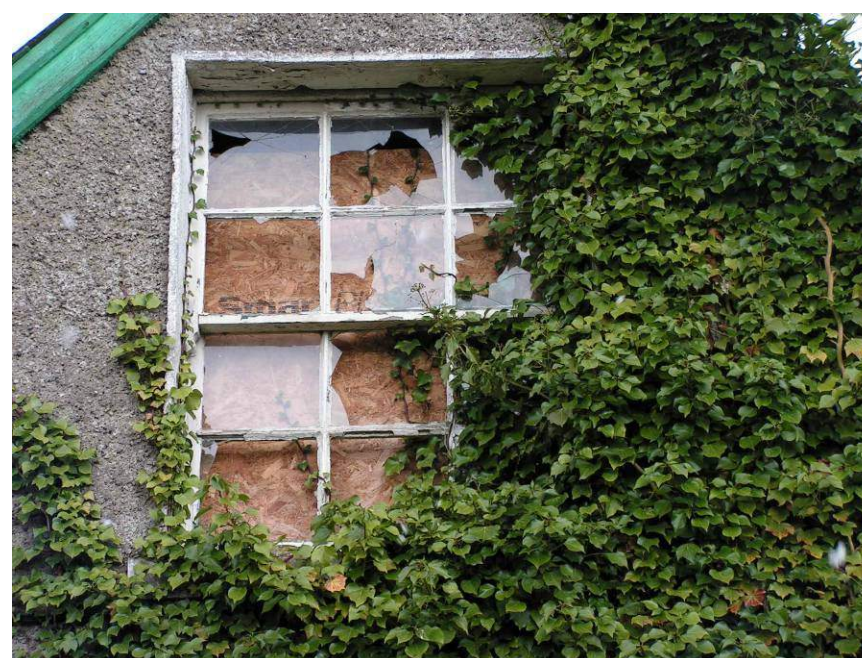
Fig. 7.6. 2 Millview Terrace. A closer view of one of the windows (March 2013)

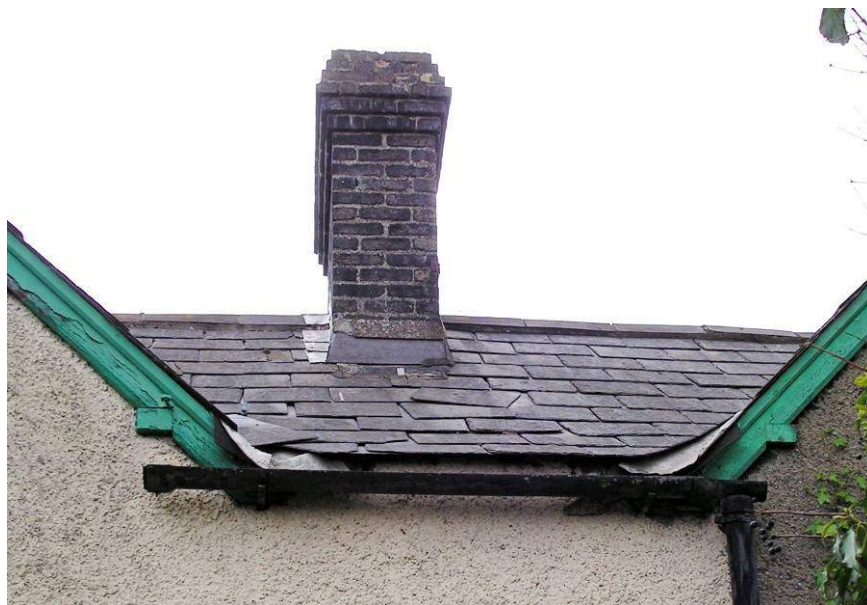
Fig. 7.8. Slipped slates above numbers 2 and 3 Millview. Note also the decay in the verge, the eroded flaunching mortar at the top of the chimney and the absence of any chimney pots. (May 2011)

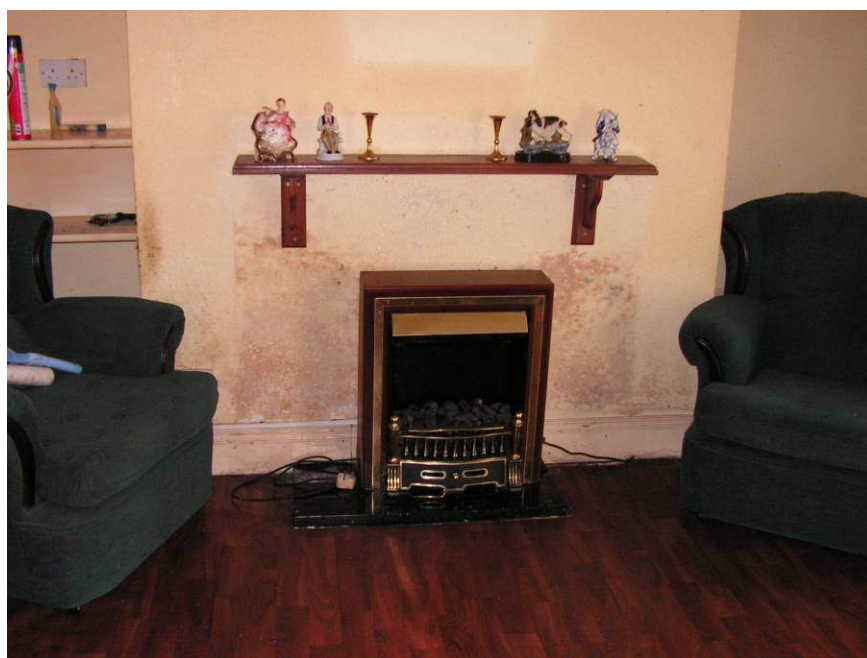
Fig. 7.9. Ground floor of number 3 Millview. Moisture in the base of the chimney stack, probably caused by lack of ventilation of the flue and deterioration of the top of the chimney above. (May 2011)

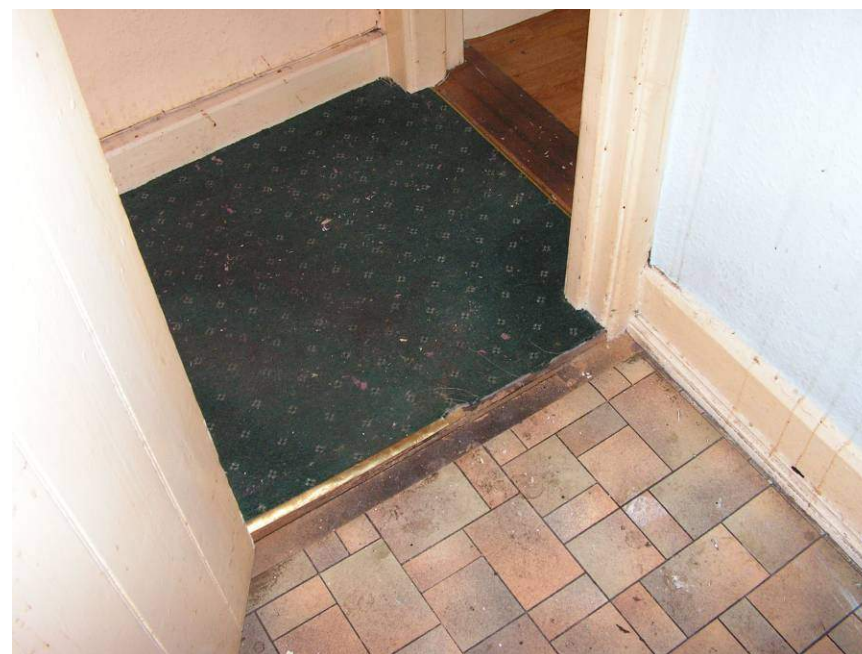
Fig. 7.10. First floor of number 3 Millview Terrace. The carpet covered floor of the landing has failed structurally and there is significant bounce. (May 2011)

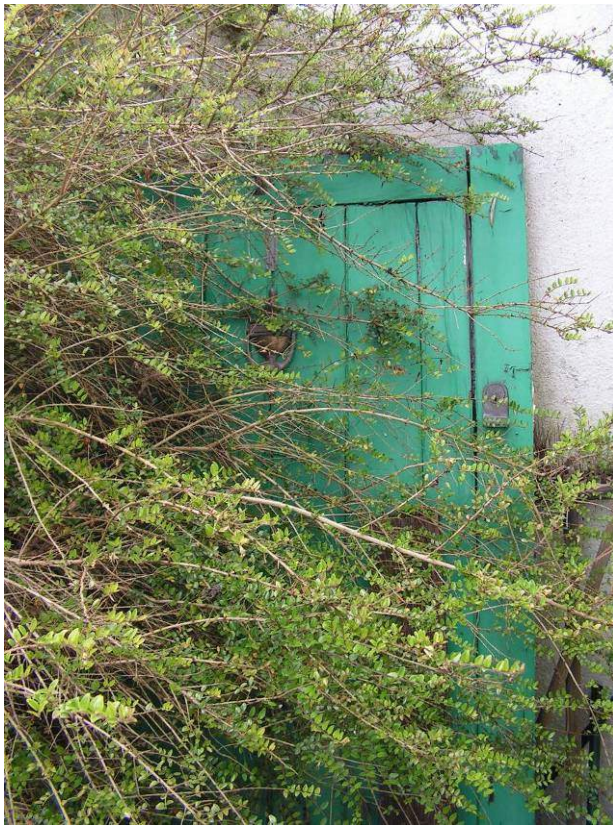
Fig. 7.11. 3 Millview. The door was stored in the back yard. (May 2011)

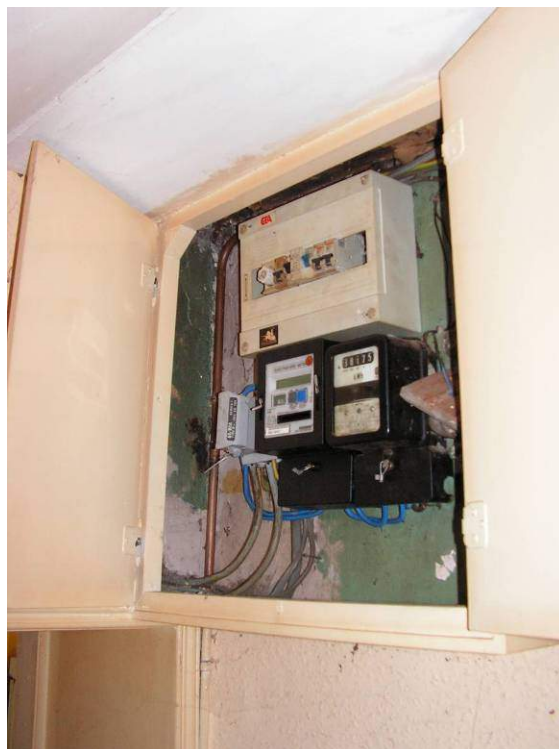
Fig. 7.15. The electrical circuit board in number 3 Millview. (May 2011)

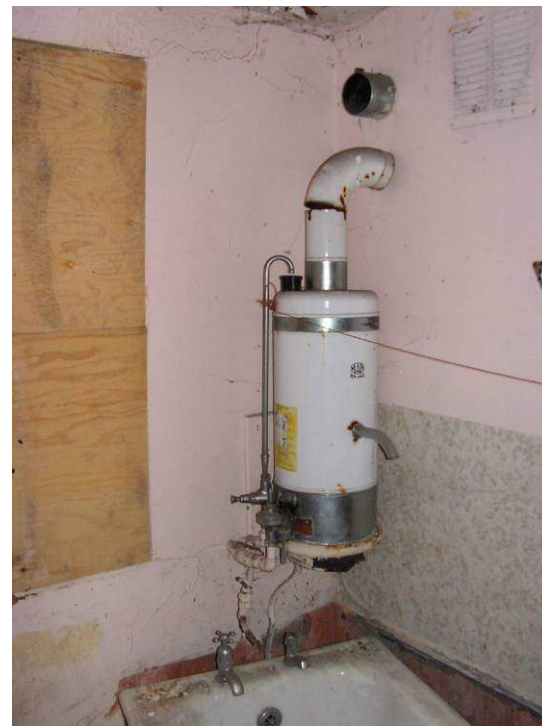
Fig. 7.16. A water heater and bath in the rere extension of 2 Millview Terrace. (March 2013)

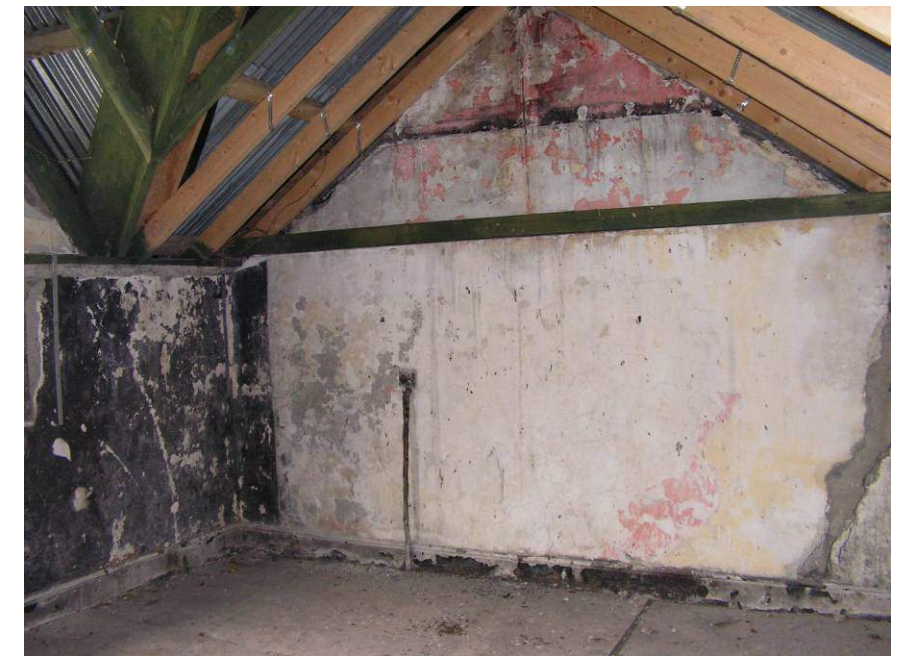
Fig. 8.1. 1 Millview Terrace. The party wall with number 2 Millview Terrace from the first floor room. Note the damage caused by fire and the crack in the right side of the photograph. (March 2013)

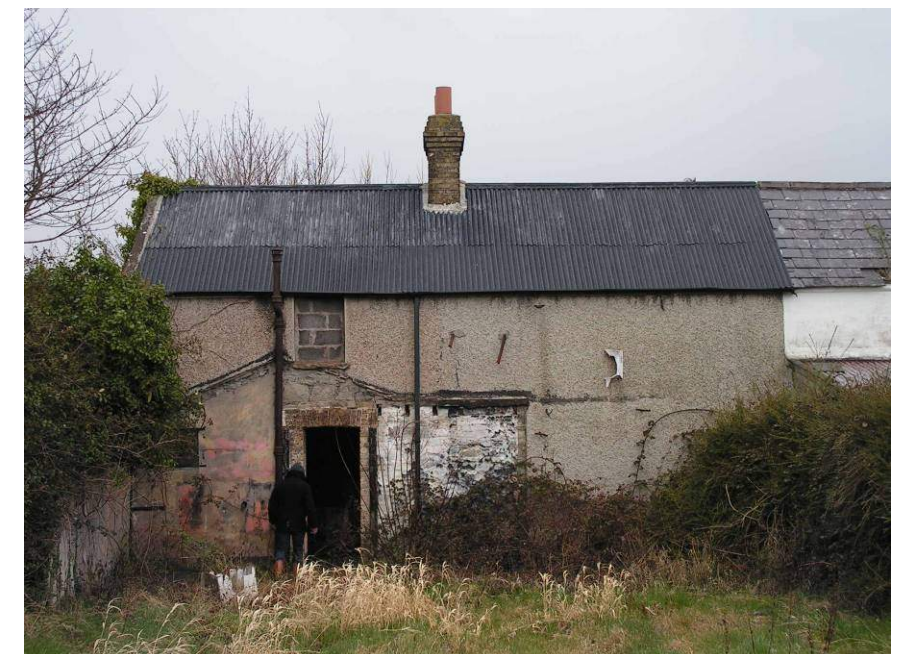
Fig. 8.2. The rere façade of 1 Millview Terrace. The outline of the demolished extension on the rere façade is clear. The side wall of the extension remains on the left side of the photo, just inside the boundary wall which is concealed in the hedge further to the left. (March 2013)

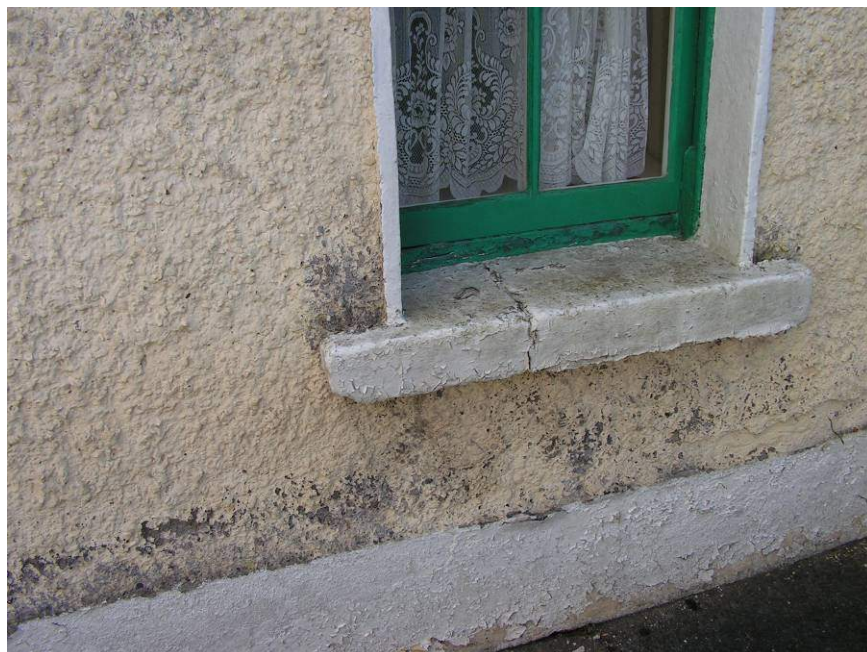
Fig. 8.3. A cracked and broken cill in number 3 Millview Terrace. The cause of the crack is not yet understood. (May 2011)

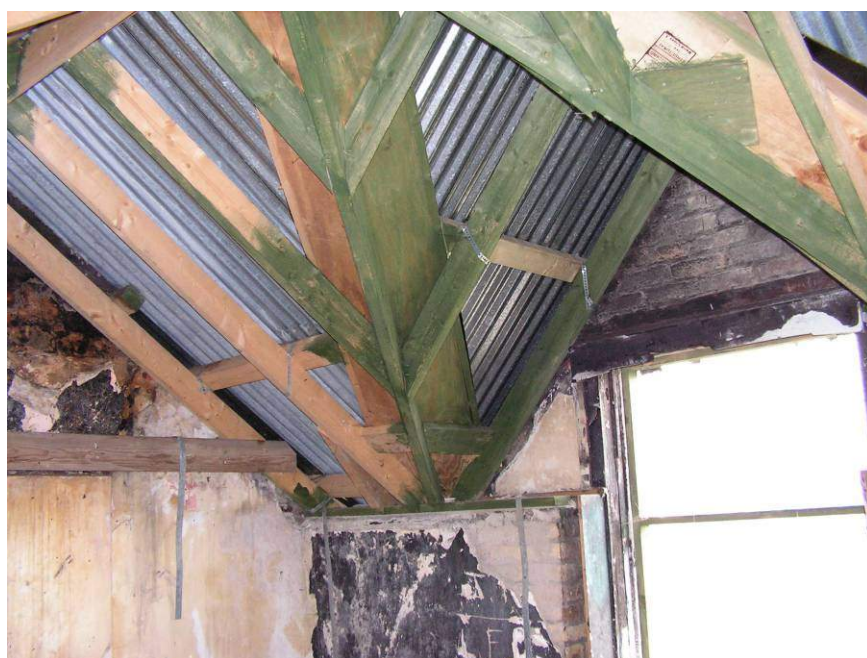
Fig. 8.4. The new roof of 1 Millview Terrace, installed after the houses was severely fire-damaged. (March 2013)

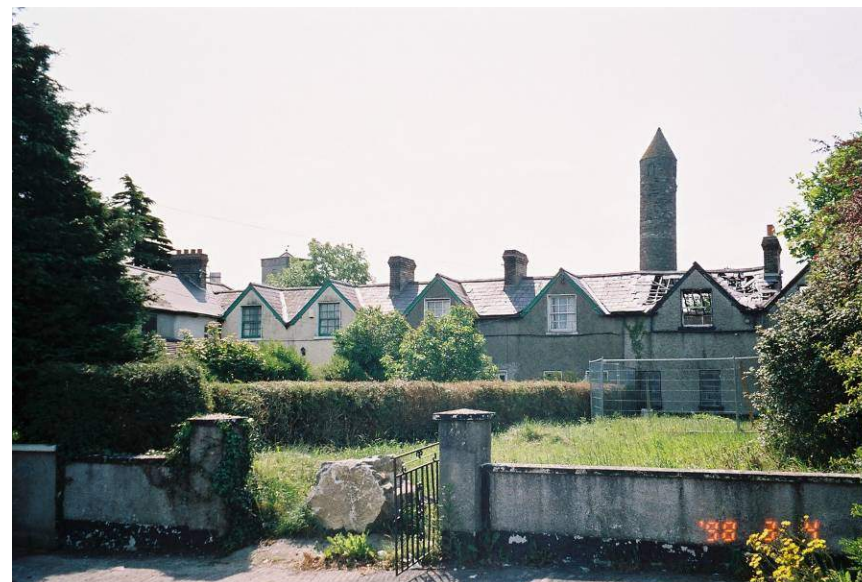
Fig. 8.5. A view of the fronts of the houses at Millview Terrace, May 2007 (the date on the bottom right corner of the photo is incorrect). The fire-damage to the roof of number 1 is visible. This has since been stripped and re-covered with a new corrugated sheet on a new roof structure. Note the absence of any breaches in the roofs of numbers 2 and 3 and the general good appearance of the front windows; the condition of these roofs and windows have deteriorated rapidly in the 7 years since this photograph was taken. Neglect and vandalism are the causes. Compare this view with more recent views on Figures 7.3 and 7.5 on page 79. (Photo courtesy of South Dublin County Council's Architectural Services department)

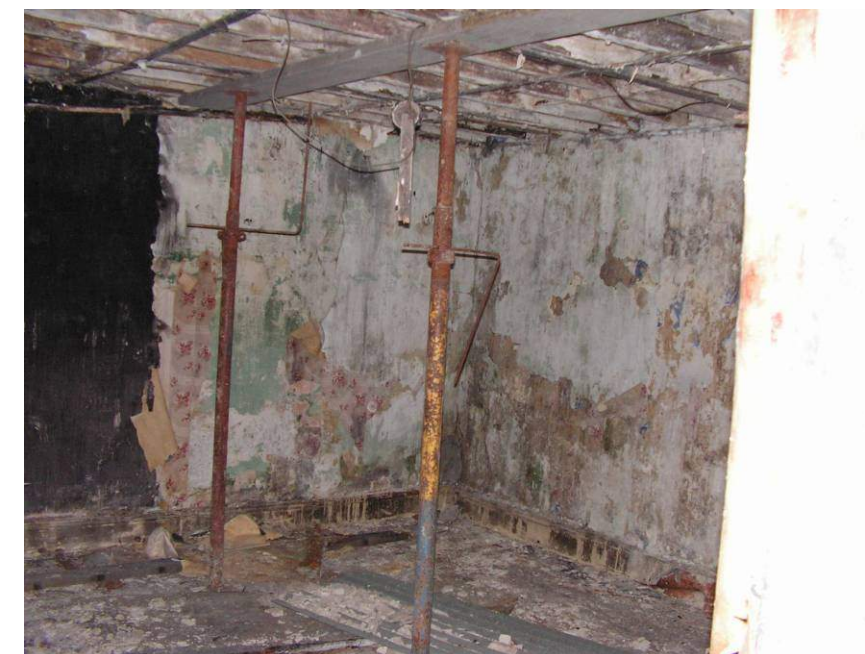
Fig. 8.6. Temporary propping of the floor in 1 Millview Terrace. (March 2013)

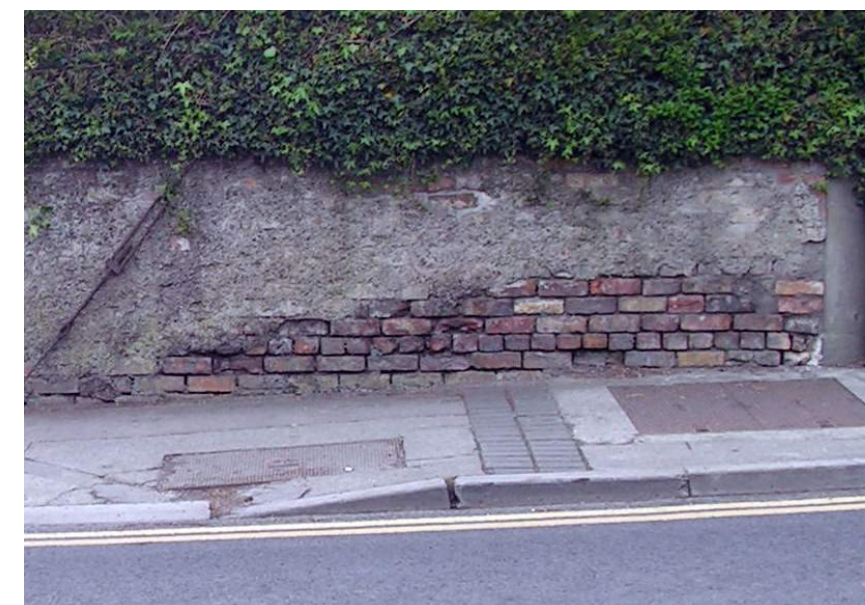
Fig. 11.1. The front boundary wall of number 3 Millview to the old Nangor Road. The brick wall urgently needs to be re-pointed. (May 2011)

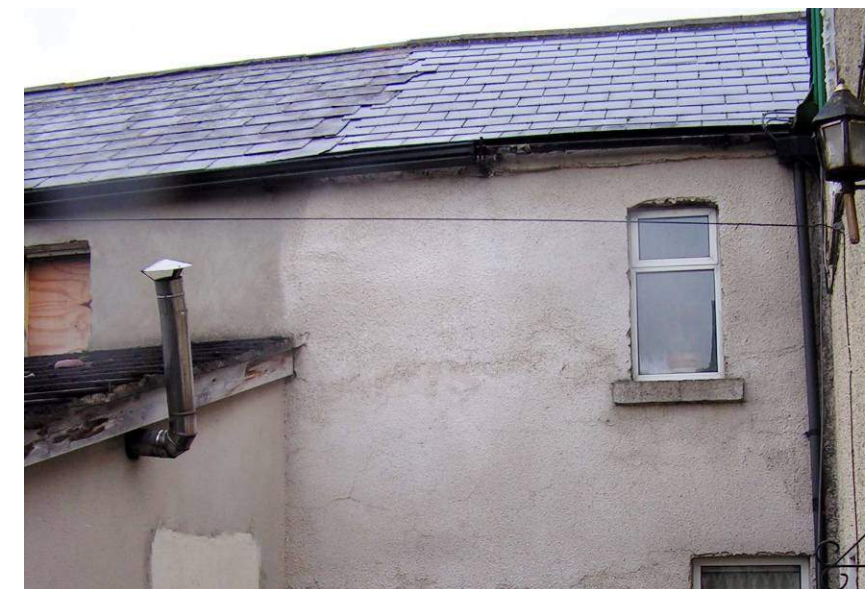
Fig. 11.4. Biofilms on the render at the back of numbers 15 and 16. Note also the missing gutter, the decayed timber on the left foreground and the crude openings made in the back of the houses. Number 16 (left) is roofed with natural slate, number 15 with artificial fibre cement slates. The latter should be included in an asbestos survey. (January 2013)

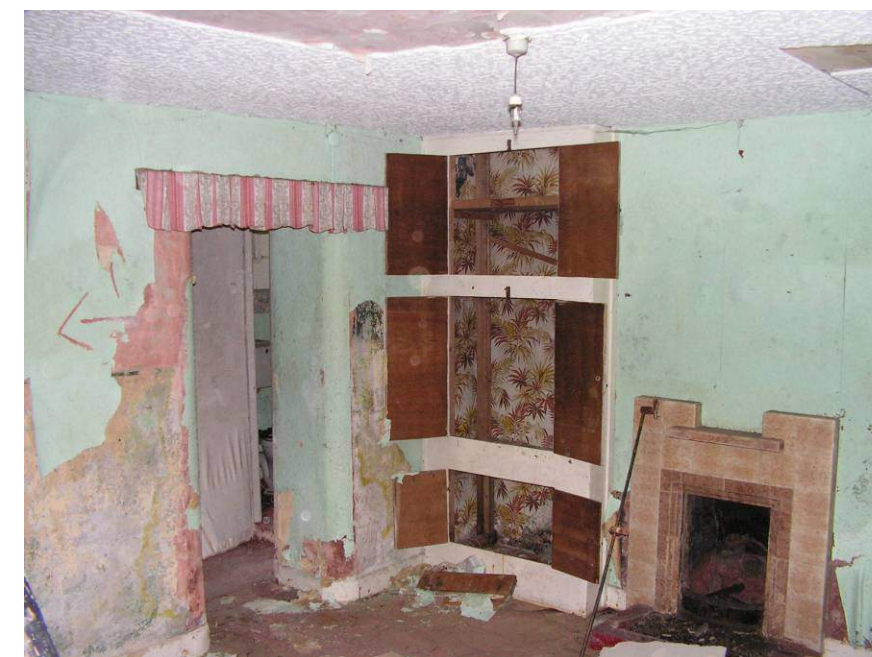
Fig. 11.5. The collared roof of 2 Millview Terrace. (March 2013)

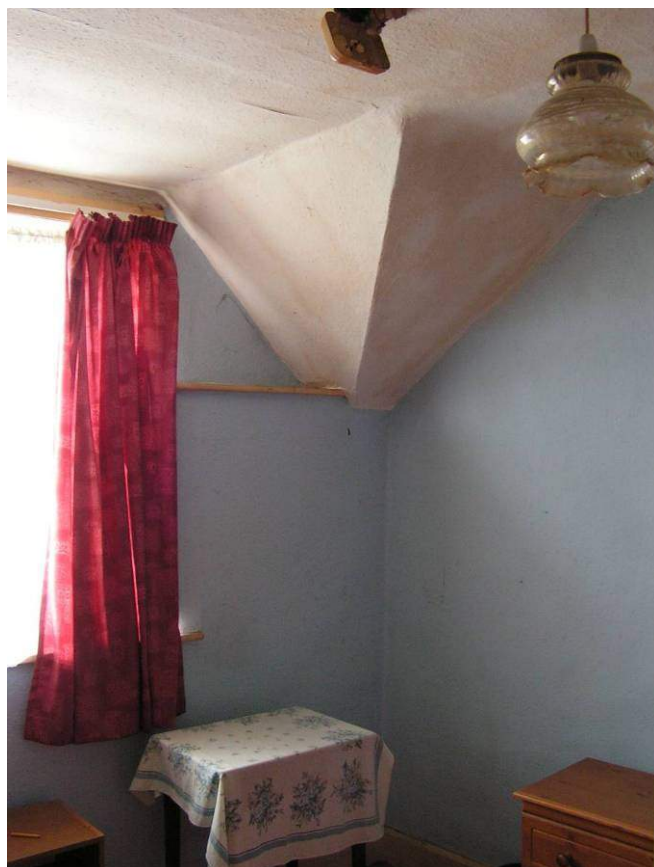
Fig. 11.6. Stained plaster and peeling wallpaper as a result of water ingress from above, first floor level number 3 Millview. (May 2011)
