Architectural  
Services  
Department

## **CLONDALKIN ROUND TOWER VISITORS' CENTRE**

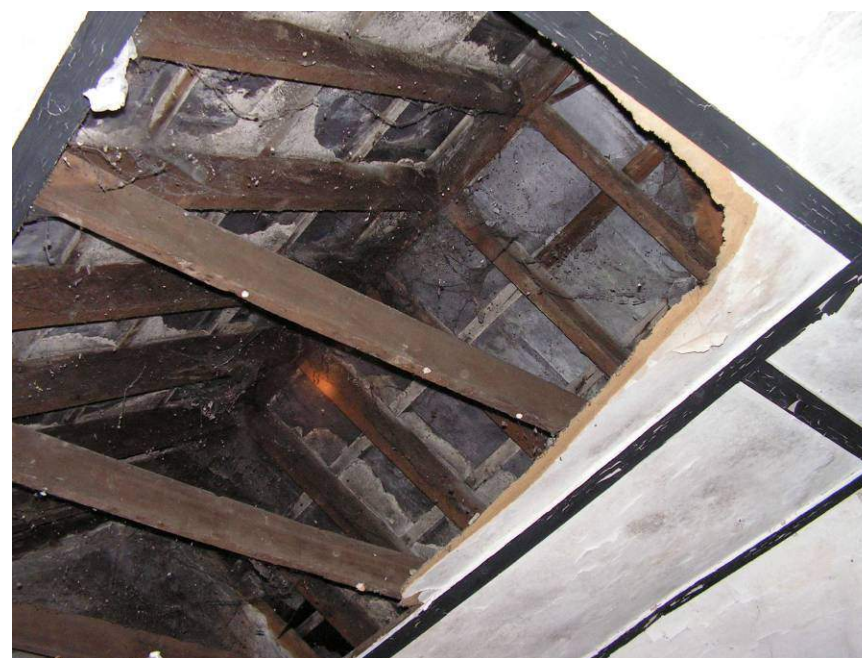
Fig. 11.7. Failure of the ceiling in 2 Millview Terrace. The parging mortar on the undersides of the slates above has also failed. (March 2013)
