Tree Survey Report

Grange Road,
Rathfarnham,
Dublin 16

| Project No. | Project name | Date | Revision |
|---|---|---|---|
| TGRA001 | Grange road Cycle corridor | 2/10/15 | - |

CMK
Horticulture & Arboriculture

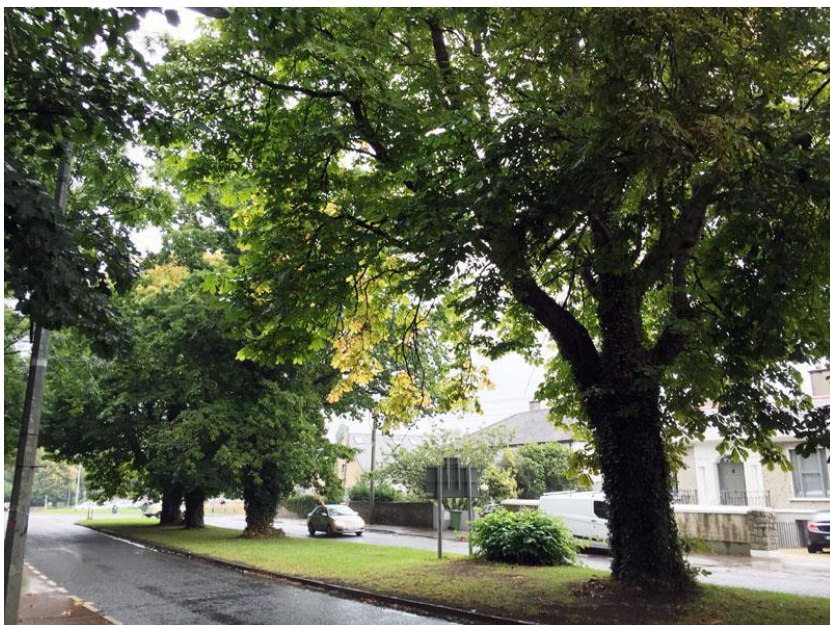
A group of large horse chestnuts and oaks located within central median near the intersection of Nutgrove avenue and Grange road.

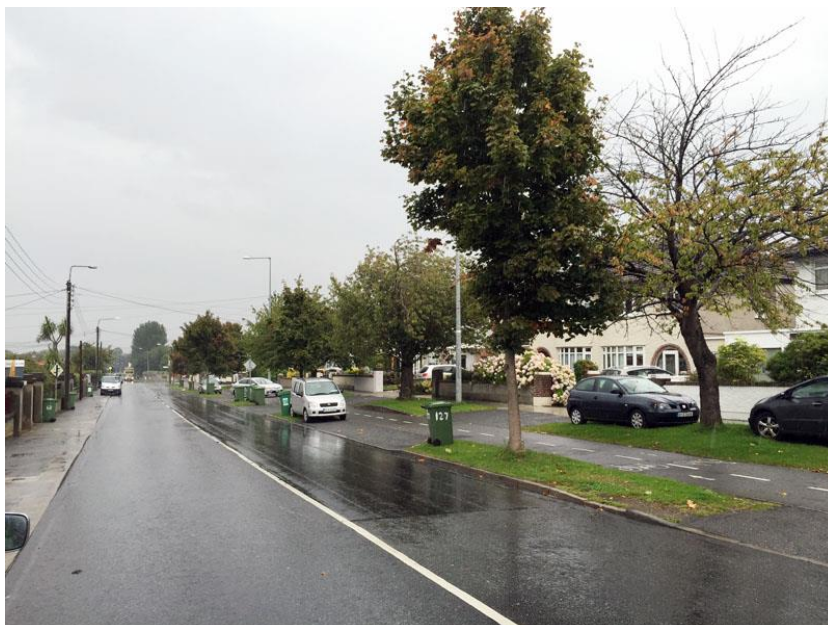
Showing a section of the Grange road north of Sarah Curran Ave.
A mix of mostly cherry and Norway maple.

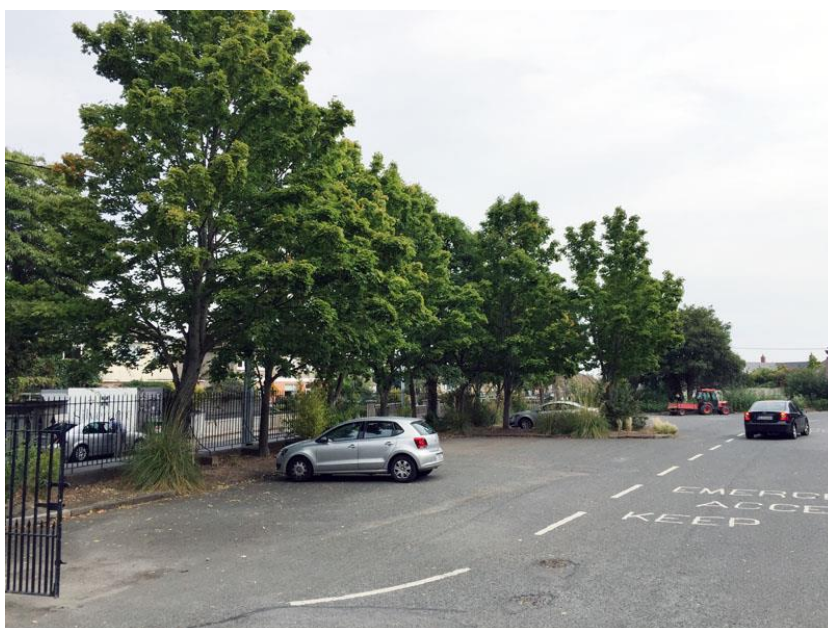
Internal view of St. Enda's carpark, immediately inside the entrance
from Sarah Curran Ave.

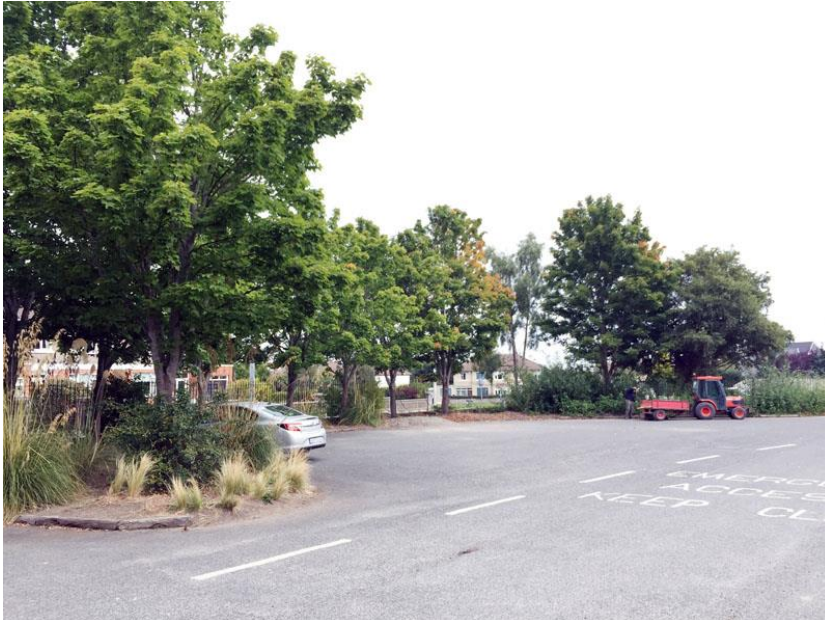
Internal view of St. Enda's carpark, a row of Norway maple along the northern boundary fence.

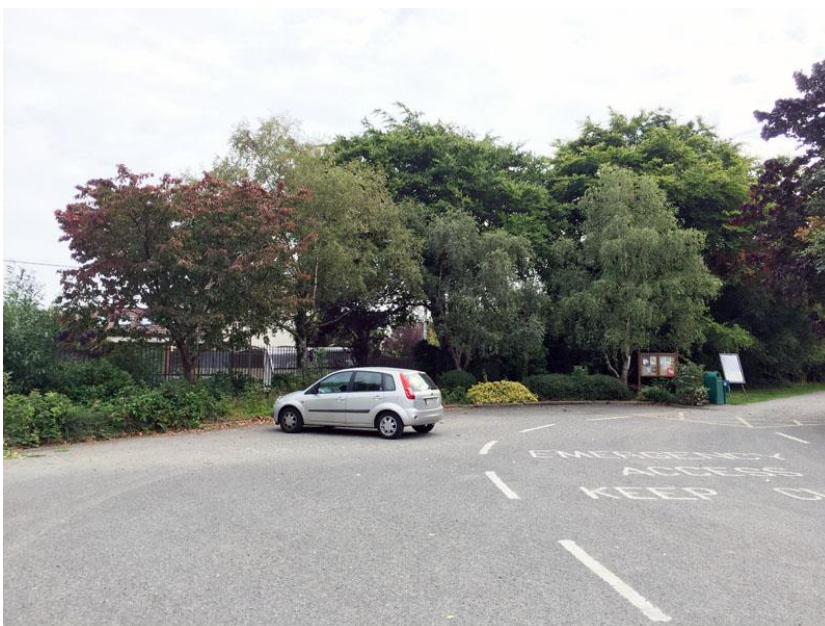
St. Enda's park carpark, a line mixed birch, beech and cherry along the eastern boundary.

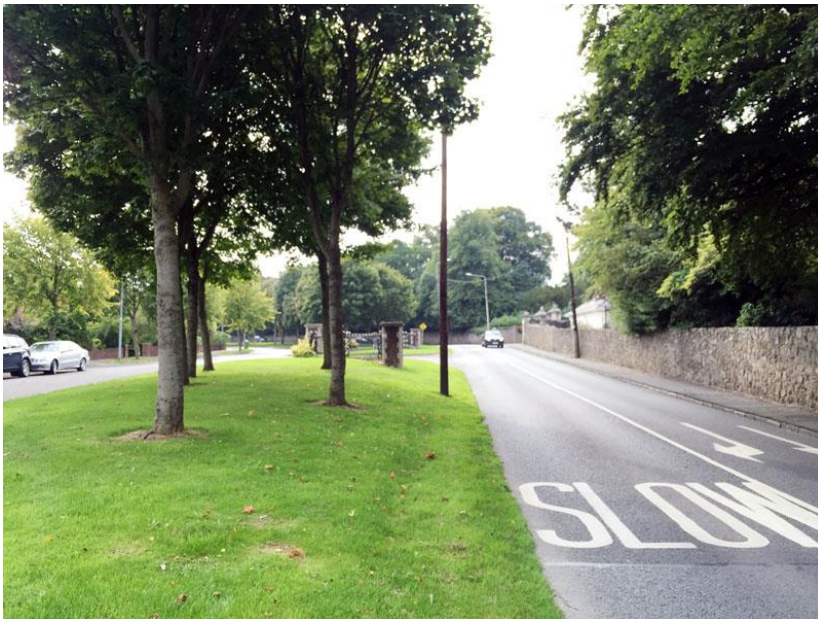
Norway maple trees along an open space between Grange road and Park Avenue.

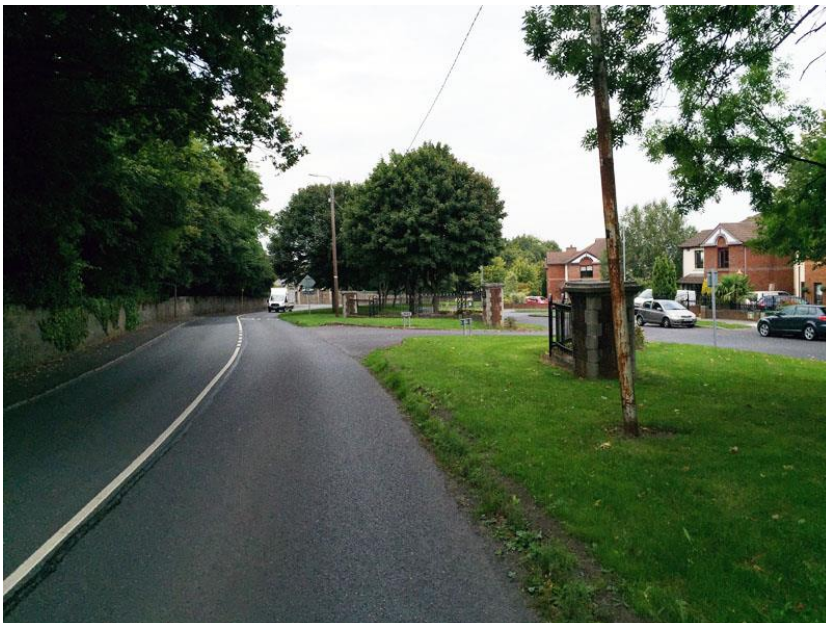
Continuation of Norway maple trees along an open space between Grange road and The Priory.

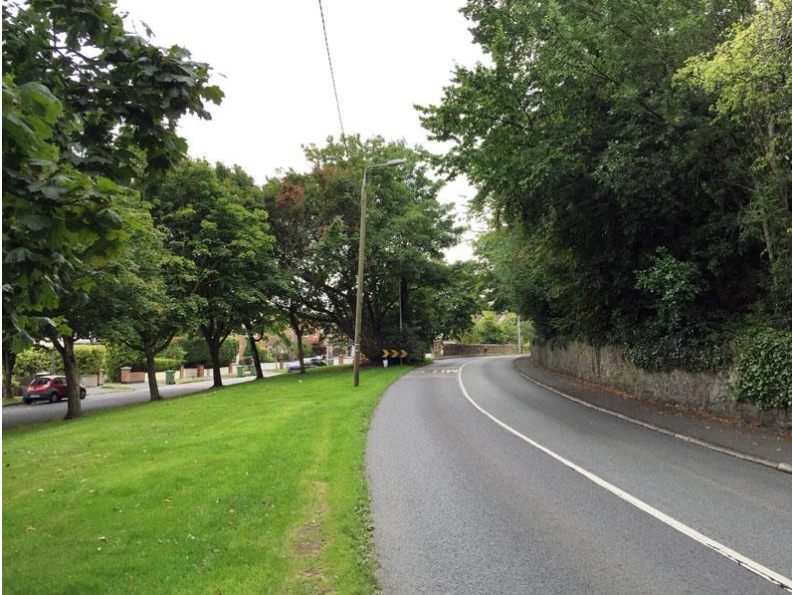
Shown in the background. Mature native tree beside an old boundary wall, these trees pre-date the neighbouring houses.
