CUNNANE STRATTON REYNOLDS

TREE SURVEY

DUBLIN MOUNTAINS, VISITOR CENTRE.

June 2017

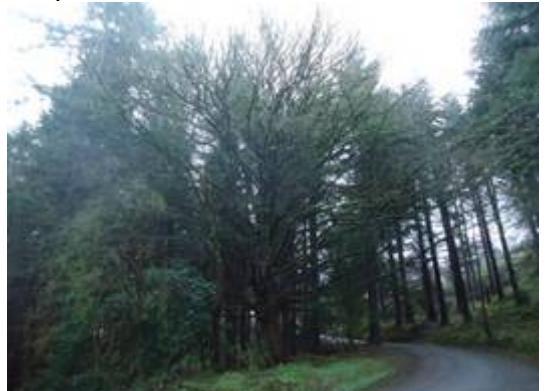
Sycamore at hairpin bend

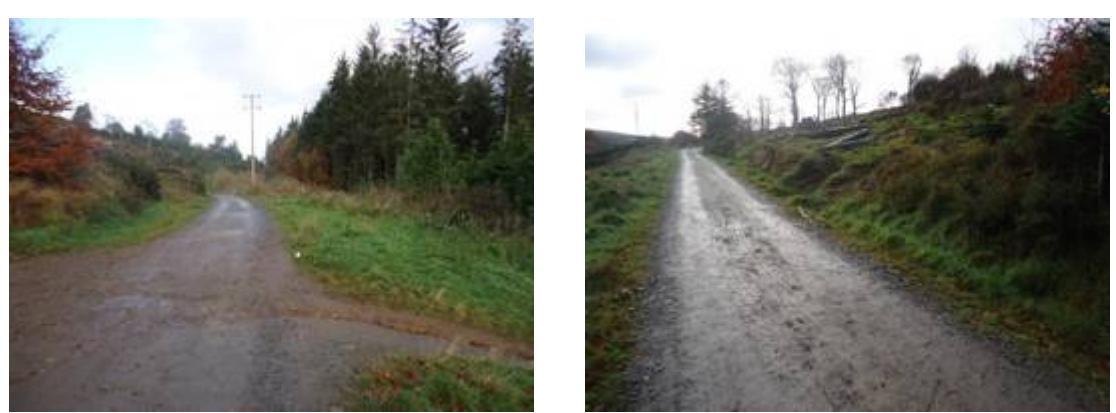
Upper level of plantation / area of recent clearfell

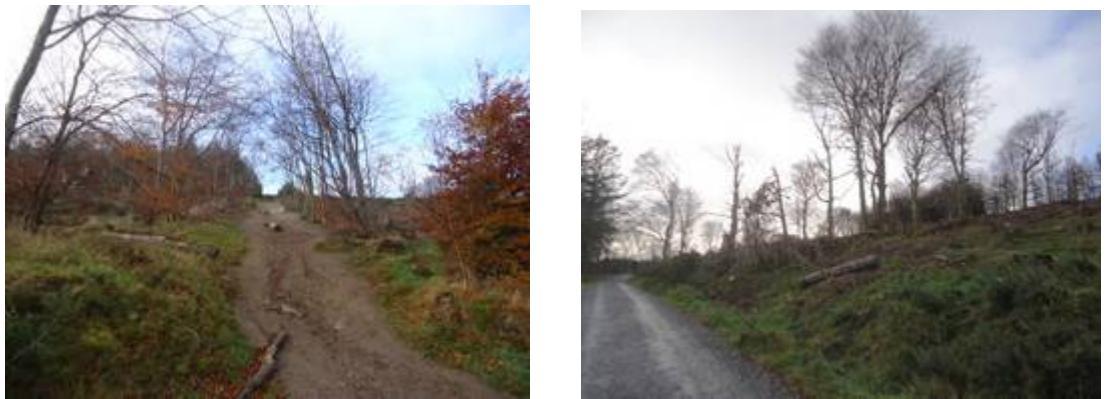
Area of recent plantation clear-fell with remnant Beech trees

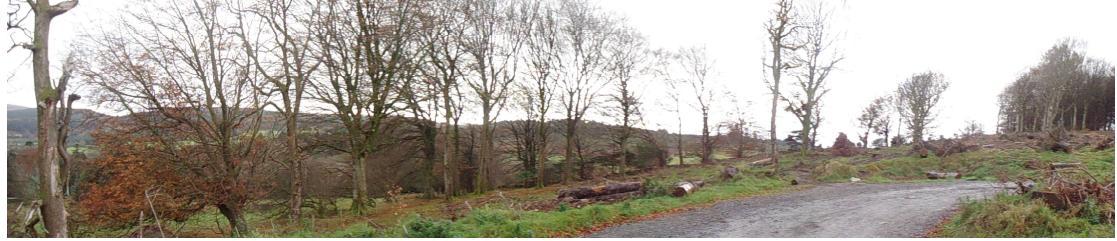
Area of recent plantation clear-fell with remnant Beech trees

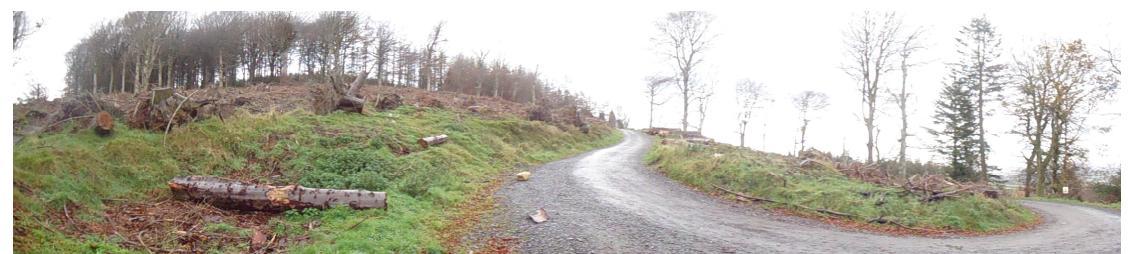
Area of recent plantation clear-fell with remnant Beech trees

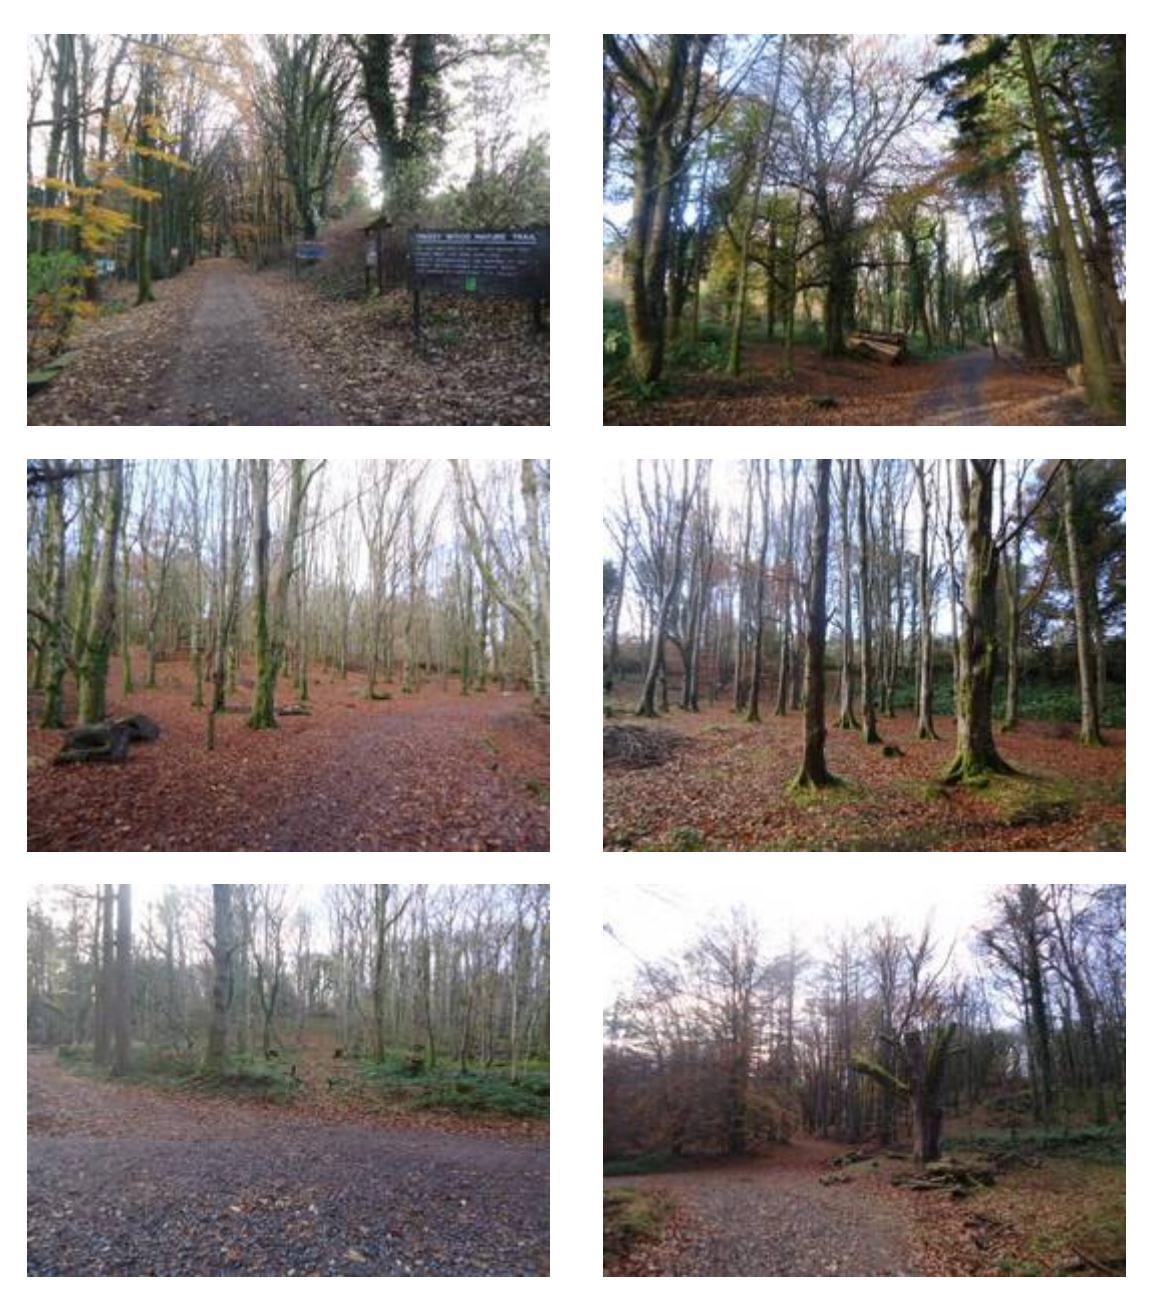
2.2b Photographic Summary of Trees Surveyed – Area 2 Massys Woods

Those trees located in Area 2, close to the location of the proposed aerial walkway, include a number of exceptionally fine standalone individuals of considerable maturity and size. A mix of species are present, predominantly Beech and Oak but also some Sweet Chestnut and Sycamore, creating a closed canopy woodland. Age profile varies from young to mature, the majority being mature.
