Grange Road Cycle Route
– Stage 1 Road Safety Audit

Job No 60302419

AECOM has been commissioned by South Dublin County Council (SDCC) to undertake a Stage 1 Road Safety Audit of the proposed cycle/pedestrian scheme on Grange Road in Rathfarnham, Co. Dublin.

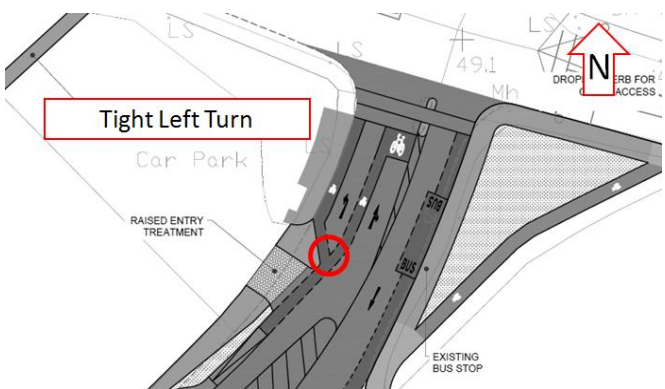
4.1.3 Problem

<i>Location:</i>	Grange Road / Nutgrove Avenue Approach	
<i>Drawing:</i>	Drg. No. 60302419_P_001, General Arrangement Sheet 1 of 3	
<i>Summary:</i>	The left turn may be too tight for cyclists	
<i>Description:</i>		Figure: Tight Horizontal Transition Points at Northbound bus stop
<p>The left turn radius proposed appears to be too tight and could result in cyclists crossing into the traffic lane, which could result in a collision with a vehicle.</p>		
Recommendation:		
<p>Use reverse curves on footpath kerbs, reflecting more closely traffic movement to provide a smoother radius for cyclists.</p>

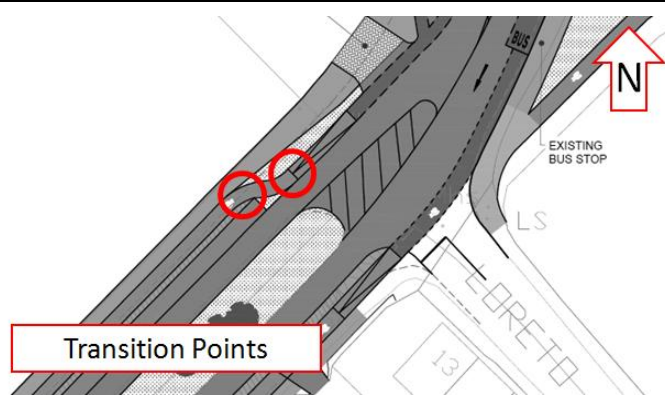
4.1.4 Problem

<i>Location:</i>	Grange Road / Nutgrove Avenue Approach	
<i>Drawing:</i>	Drg. No. 60302419_P_001, General Arrangement Sheet 1 of 3	
<i>Summary:</i>	The horizontal transition may be too tight for cyclists	
<i>Description:</i>		Figure: Tight Horizontal Transition Points at Northbound bus stop
<p>Transitions should be designed and constructed to provide continuity, comfort and safety to cyclists. The curve radius of a transition should permit cyclists to preserve momentum and maintain their balance. The curve radius proposed appears to be too tight and could result in cyclists losing control of their bikes, resulting in injury.</p>		
Recommendation:		
<p>The proposed transition should be increased in length with a larger radius used. For cycle routes in an urban area, a curve radius of 20.0m is recommended in the National Cycle Manual to accommodate cyclists travelling at 30km/h.</p>

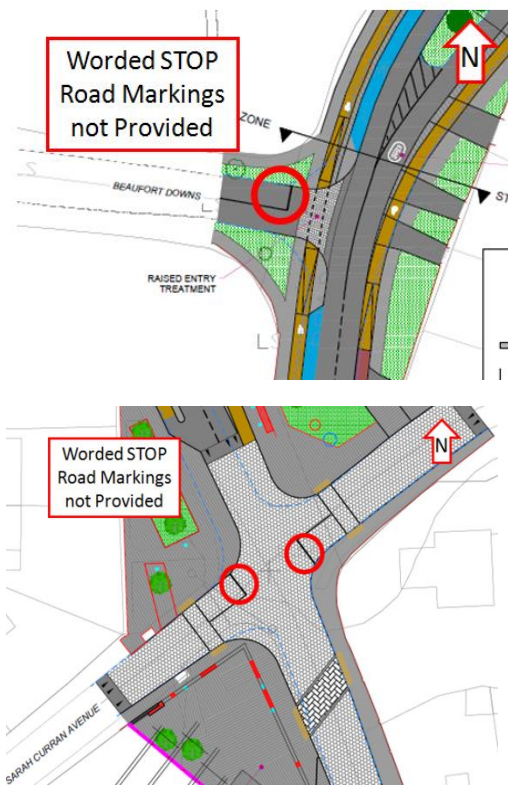
4.2.1 Problem	
<i>Location:</i>	Throughout the scheme
<i>Drawing:</i>	Drg. No. 60302419_P_001, General Arrangement Sheets 1 to 3
<i>Summary:</i>	Motorist failing to stop at the stop line.
<i>Description:</i>

<p><i>Figure: Control road markings not provided on minor arms throughout the scheme</i></p>	
<p>The lack of the STOP worded road marking (M 114) increases the possibility that drivers on the minor approach will fail to take account of other road users, particularly pedestrians and cyclists at the junction which may lead to collisions with these vulnerable road users.</p>	
Recommendation:	
<p>Consideration should be given to providing STOP worded road markings to increase conspicuity of the junction.</p>

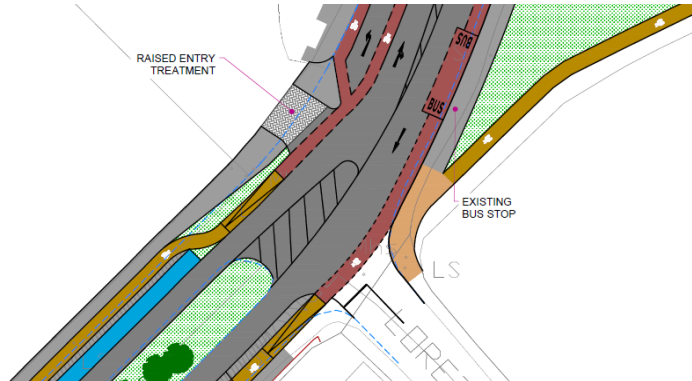
4.2.2 Problem

<p>Figure: Proposed Road Markings at the Grange Road / Loreto Terrace junction</p>
Location:	Grange Road / Loreto Terrace / Car Park	
Drawing:	Drg. No. 60302419_P_001, General Arrangement Sheet 1 of 3	
Summary:	Potential side impact collisions	
Description:		
<p>There is an existing yellow box provided throughout the junction to allow exit from both Loreto Terrace and Car Park. Motorists may take a risk in edging out onto the road carriageway hoping to get through a gap in the traffic. If a gap is not available they may be at risk of side impact collisions.</p>		
Recommendation:		
<p>Consideration should be given to providing a smaller yellow box in front of Loreto Terrace and the car park, to provide a space where motorists can exit from the minor arms.</p>

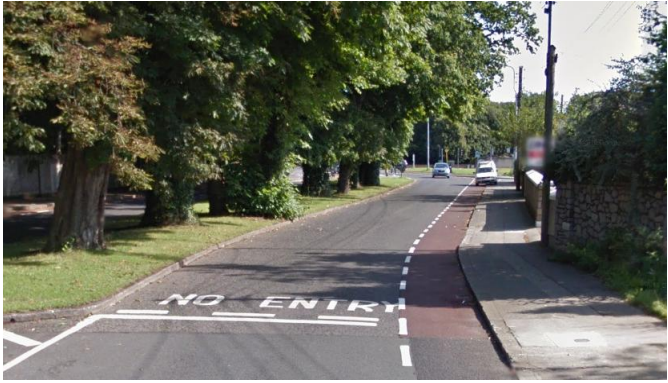
4.2.3 Problem

<p>Photo: Existing 'No Entry' Road Markings</p>
Location:	Grange Road	
Drawing:	Drg. No. 60302419_P_001, General Arrangement Sheet 1 of 3	
Summary:	Potential head-on vehicle collision	
Description:		
<p>The existing 'No Entry' road markings are not proposed in the schemes drawings, which could result in some driving in the incorrect direction on Grange Road. Driving in the incorrect direction could lead to a collision with southbound vehicles.</p>		
Recommendation:		
<p>The existing 'No Entry' road markings should be replaced.</p>

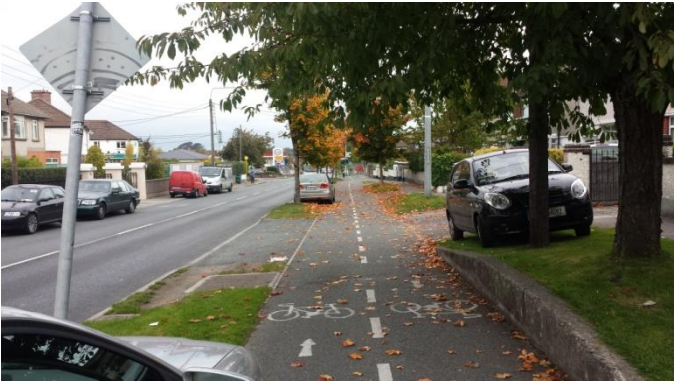
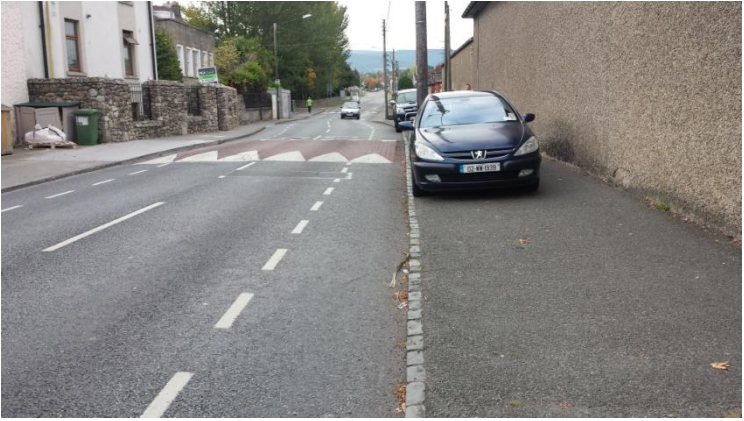
4.2.4 Problem

<p>Photo: Parking noted south of St. Enda's Drive on Grange Road</p>
<i>Location:</i>	Grange Road, throughout the length of the scheme	
<i>Drawing:</i>	Drg. No. 60302419_P_001, General Arrangement Sheet 1 to 3	
<i>Summary:</i>	Illegal parking on the cycle lane / tracks	
<i>Description:</i>

<p>Photo: Parking noted at Convent Lane</p>
<p>Parking has been noted on the along the Grange Road. Parking is not permitted on cycle lanes/tracks, but motorists may park on the proposed cycle facilities. Parking in the cycle facilities will result in cyclists moving either onto the road carriageway or the footpath, putting them into conflict with either motorists or pedestrians respectively.</p>		
Recommendation:		
<p>Measures should be provided to discourage motorists from parking on the cycle facilities along Grange Road.</p>

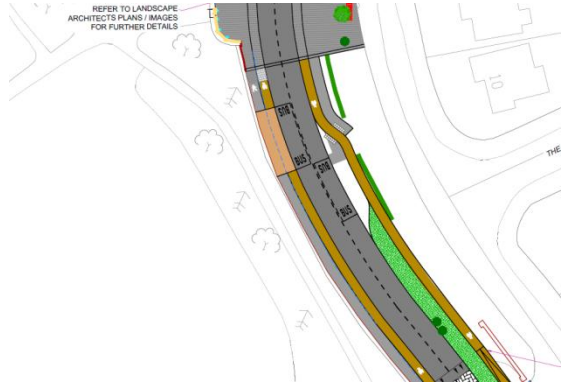
4.2.5 Problem

<p>Figure: Tramline and Ladder Tactile Paving is not provided</p>
Location:	Grange Road, throughout the length of the scheme	
Drawing:	Drg. No. 60302419_P_103, General Arrangement Sheet 3 of 3	
Summary:	Potential pedestrian / Cyclist collisions	
Description:		
<p>Tactile paving is not provided on the transition from footpath/cycletrack to shared surface meaning that visually impaired pedestrians will be unsure as to which is the correct side for pedestrians. Tactile paving not provided on the cycle lane side of the shared surface means that visually impaired pedestrians may walk down this ramp and onto the cycle track. This would put pedestrians at risk to collisions with cyclists.</p>		
Recommendation:		
<p>Tramline and ladder tactile paving should be provided at the change to and from the shared surface area.</p>

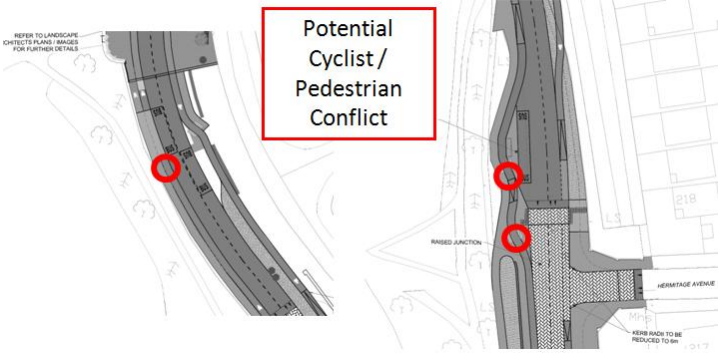
4.2.6 Problem

<p>Figure: Potential locations where conflicts could occur between pedestrians and cyclists travelling at speed downhill</p>
Location:	Downhill Sections of the Cycle Track	
Drawing:	Drg. No. 60302419_P_103, General Arrangement Sheet 3 of 3	
Summary:	Cyclists colliding with pedestrians	
Description:		
<p>High cycle speeds are likely on the approaches to the pedestrian crossings at Hermitage Avenue and the bus stop to the south of the Pearse Museum Entrance. Cyclists who fail to slow down may cause a serious collision with pedestrians in these areas.</p>		
Recommendation:		
<p>Cyclists should be made aware that they need to reduce speed at these locations. Consideration should be given to providing cyclist rumble strips and yield road markings adjacent to the bus stop.</p>

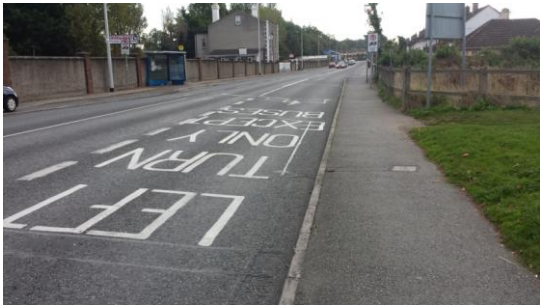
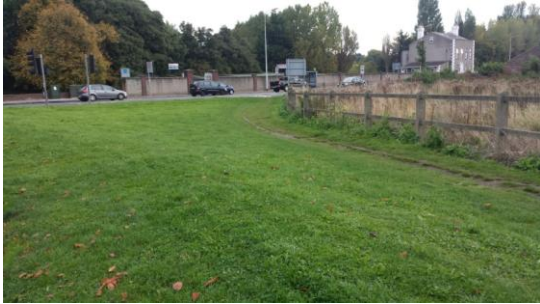
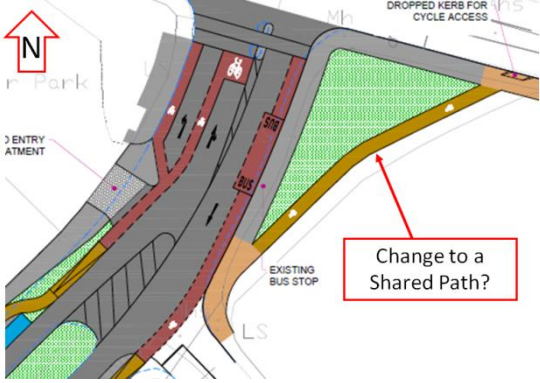
4.3.1 Problem

<p>Photo: Existing Footpath on Nutgrove Avenue</p>

<p>Photo: Existing Track through the Green</p>

<p>Figure: Proposed Cycle Lane</p>
<i>Location:</i>	Grange Road / Nutgrove Avenue Approach	
<i>Drawing:</i>	Drg. No. 60302419_P_001, General Arrangement Sheet 1 of 3	
<i>Summary:</i>	Existing Desire Line should also provide for Pedestrians	
<i>Description:</i>

It is proposed to provide a cycle lane through the green area at the edge of the junction. This is already a desire line for pedestrians, evidenced by the existing worn path through the grass. Therefore, it is likely that pedestrians will walk on the cycle path proposed in this location. The proposed facility appears narrow and will result in a reduced quality of service for both modes. The footpath on Nutgrove Avenue is shown as a shared footpath but it is currently a pedestrian's only footpath. The transition location from footpath to shared surface has not been specified.

The cycle track should be changed to a shared facility with a minimum width of 3.0m. Tactile paving should be provided on the transition from the footpath to shared surface to ensure that pedestrians, in particular, the visually impaired are aware of the presence of cyclists.

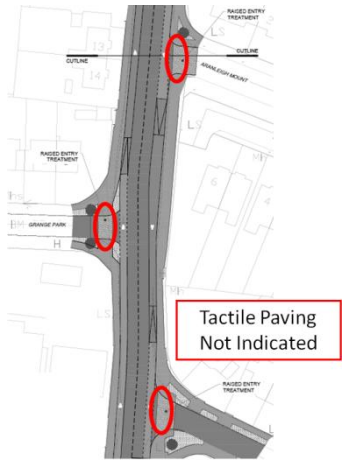
4.3.3 Problem

<i>Location:</i>	Throughout Scheme	
<i>Drawing:</i>	Drg. No. 60302419_P_001, General Arrangement Sheets 1, 2 and 3	
<i>Summary:</i>	Tactile Paving not shown at any of the proposed crossing locations.	
<i>Description:</i>		Figure: Tactile Paving Not Indicated on the Drawings

Tactile paving has not been indicated at some of the proposed crossings in the scheme. Tactile paving is used to warn of crossing locations and used as a guide across the road carriageway. The lack of tactile paving may result in pedestrians crossing the road carriageway unaware that they may be in conflict with vehicles, resulting in a collision.

Dropped kerbs and tactile paving should be provided in accordance with the ‘Guidance on the Use of Tactile Paving’, and should be provided at all appropriate locations and orientation to direct pedestrians in the correct direction.

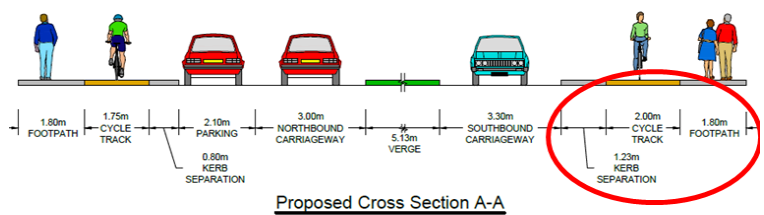
4.3.4 Comment	
Location:	Grange Road at Section A-A
Drawing:	Drg. No. 60302419_P_001, General Arrangement Sheet 1 of 3
Summary:	Reduced Pedestrian Footpath
Description:	
<p>It is proposed to slightly reduce the existing pedestrian footpath on this section of the route. However, it is proposed to provide a kerb separation of 1.23m wide on the eastern side of the road, which is not required. The proposed footpath width should be maximised to wide as possible.</p>	
Recommendation:	
<p>A clear width of 2000mm is recommended in the National Disability Authority's "Building for Everyone" to enable people to walk alongside each other and for two wheelchair users or parents with strollers to pass comfortably.</p>

Figure: Proposed Cross Section on Grange Road

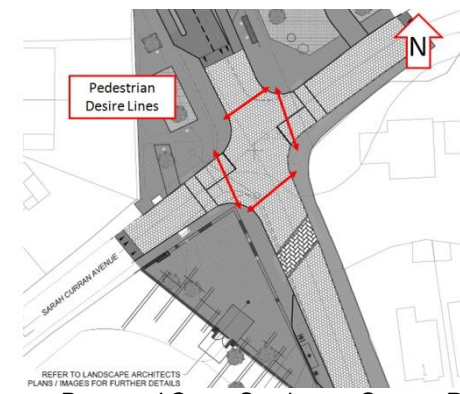
4.3.5 Problem	
Location:	Grange Road / Sarah Curran Avenue
Drawing:	Drg. No. 60302419_P_001, General Arrangement Sheet 2 of 3
Summary:	Proposed Pedestrian Crossing off the Desire Line
Description:	
<p>The crossings at this junction are located off the pedestrian desire lines. Significant proportions of pedestrians and cyclists will not inconvenience themselves by travelling the extra distance to formal facilities and may be prepared to take the risk of crossing away from the formal crossing point. With pedestrians crossing at numerous locations it will increase the risk of a collision with vehicles.</p>	
<p>An uncontrolled crossing has not be provided on the northern side of the junction.</p>	
Recommendation:	
<p>It is important that crossings are sited where the maximum number of people are likely to use them. The uncontrolled crossings should be sited closer to the pedestrian desire line.</p>	
<p>An uncontrolled crossing should be provided on the northern side of the junction.</p>

Figure: Proposed Cross Section on Grange Road

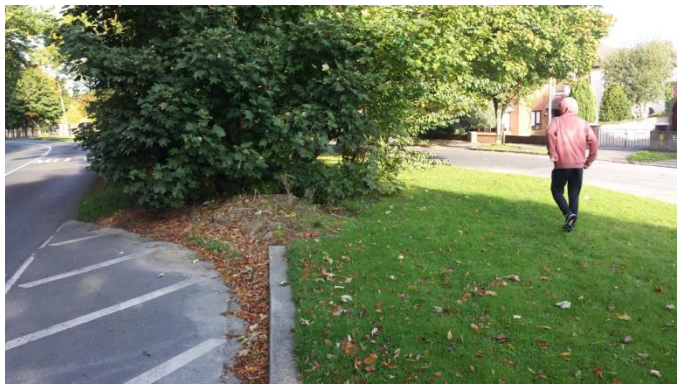
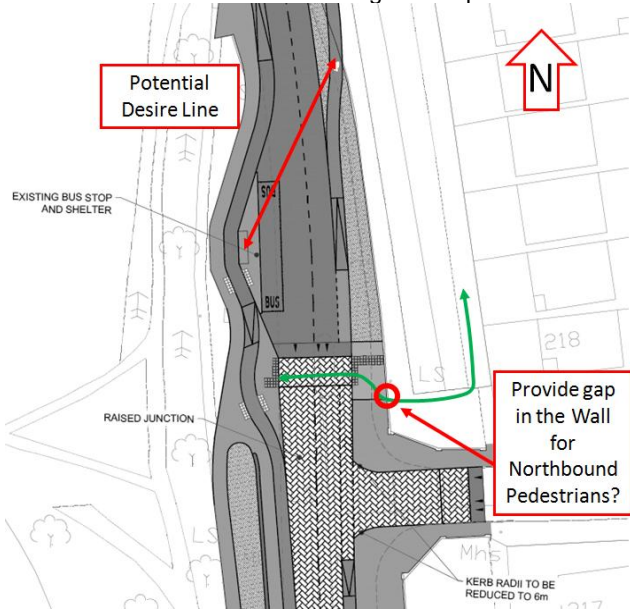
4.3.7 Problem	
Location:	Grange Road / Nutgrove Avenue Approach
Drawing:	Drg. No. 60302419_P_001, General Arrangement Sheet 1 of 3
Summary:	Existing Desire Line should also provide for Pedestrians

Photo: Pedestrian after crossing the road to the north of the existing bus stop

Figure: Proposed Cycle Lane

It is proposed to provide a controlled crossing to the north of the Hermitage Avenue junction. However, some pedestrians were noted to cross the Grange Road further north. The proposed crossing won't provide a direct route for northbound pedestrians. Therefore, many pedestrians will continue to cross to the north of the bus stop where they will be at risk of collision with vehicles.

To reduce the distance northbound pedestrians must walk, and to reduce the number of pedestrian who do not use the controlled crossing, consideration should be given to providing a gap through the existing wall into the residential estate.
