Tree Survey Report

Grange Road,
Rathfarnham,
Dublin 16

| Project No. | Project name | Date | Revision |
|---|---|---|---|
| TGRA001 | Grange road Cycle corridor | 2/10/15 | - |

CMK
Horticulture & Arboriculture

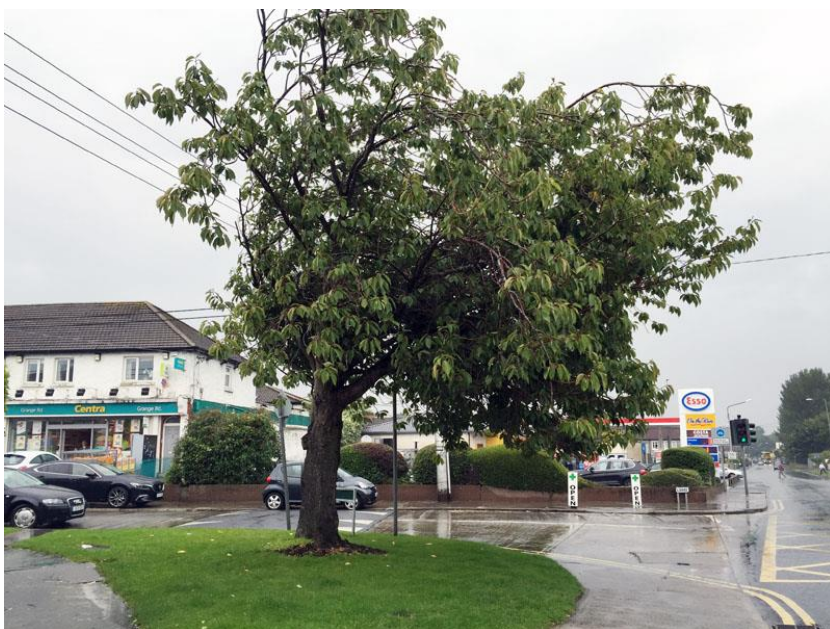
A group of large horse chestnuts and oaks located within central median near the intersection of Nutgrove avenue and Grange road.
